5 YEAR ROOF CERTIFICATION & REMAINING USEFUL LIFE ASSESSMENT

Owner's Name:		Property Address: <p style="text-align: center;">Palm Beach, FL</p>		Roof Type: <p style="text-align: center;">Concrete Tile & Flat</p>	
Contact Email:		Contact Phone #1:	Contact Phone #2:	Approx. Roof Age: <p style="text-align: center;">25 YEARS</p>	
INSPECTION DATE 5/26/2026	CERTIFICATION NUMBER MMR- 05262026	DATE OF EXPIRATION 5/26/2031	INSPECTOR LICENSE NO. CCC1331721	INSPECTOR NAME Mike McGilvary

PHOTO EXHIBIT ONE (1) – SUPPORTING DOCUMENTATION

**EXISTING ROOF CONDITIONS –
AERIAL PHOTOGRAPHIC RECORD**

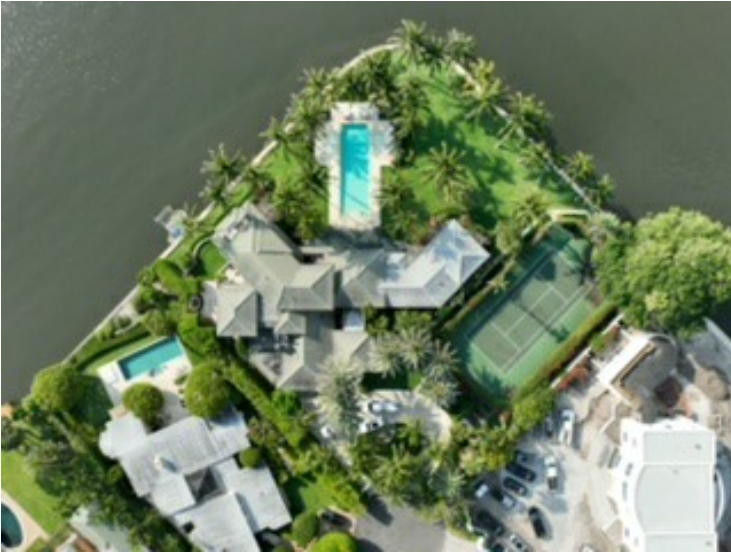
**Overall aerial view of subject property
prior to roofing Work.**

Image documents roof layout, multiple roof elevations, drainage patterns, and existing roof conditions before commencement of repairs and restoration.

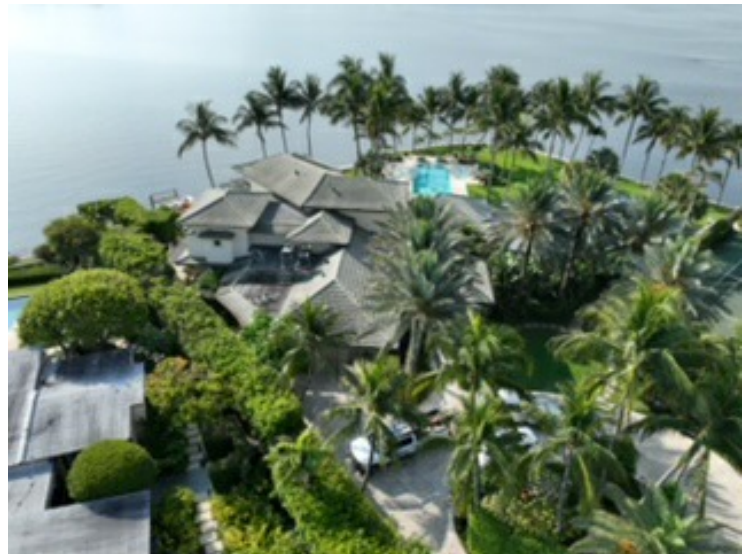
**Oblique aerial perspective of residence
prior to repairs.**

Image captures roof geometry, high-water-flow areas, valleys, transitions, flashing locations, and overall roof condition before work began.

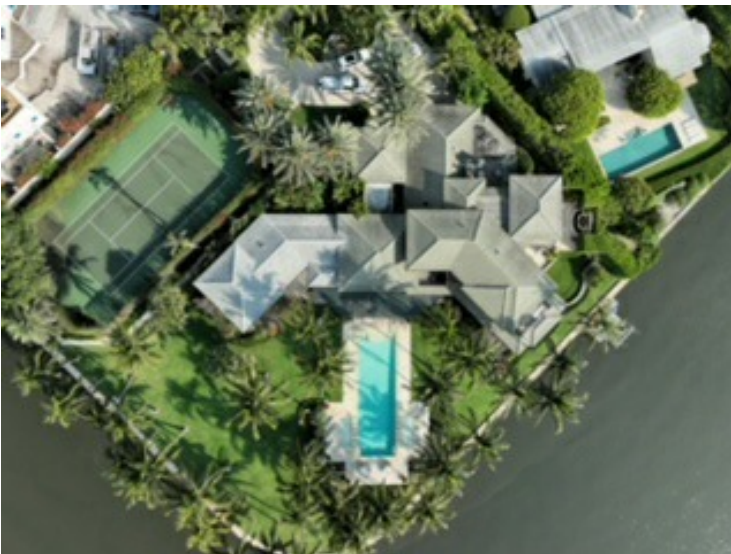
**Comprehensive overhead aerial view documenting
existing roof system before repairs.**

Photo establishes baseline roof condition and identifies all roof sections included within the scope of work and certification process.

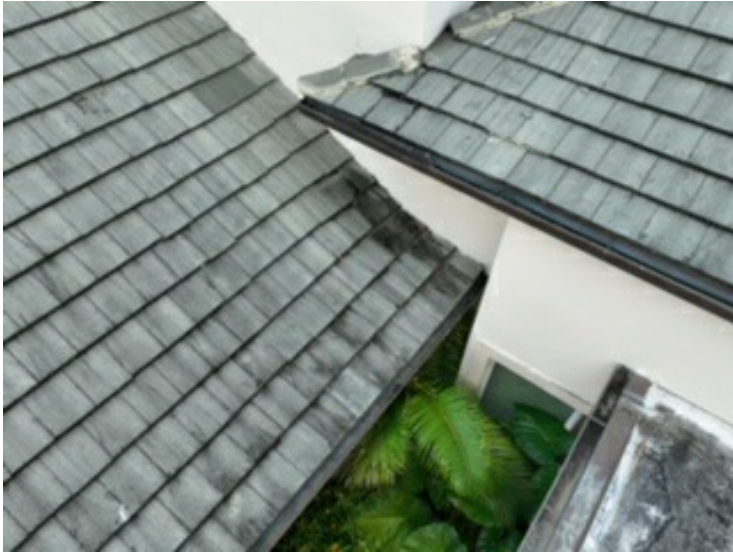
High Water Flow Area Deterioration -

This roof section receives substantially more water flow than surrounding roof areas due to the roof's slope and drainage patterns.

Dark staining and discoloration indicate prolonged moisture retention.

These areas remain wet longer after rainfall, causing accelerated aging of the underlying underlayment system and requiring reconstruction.

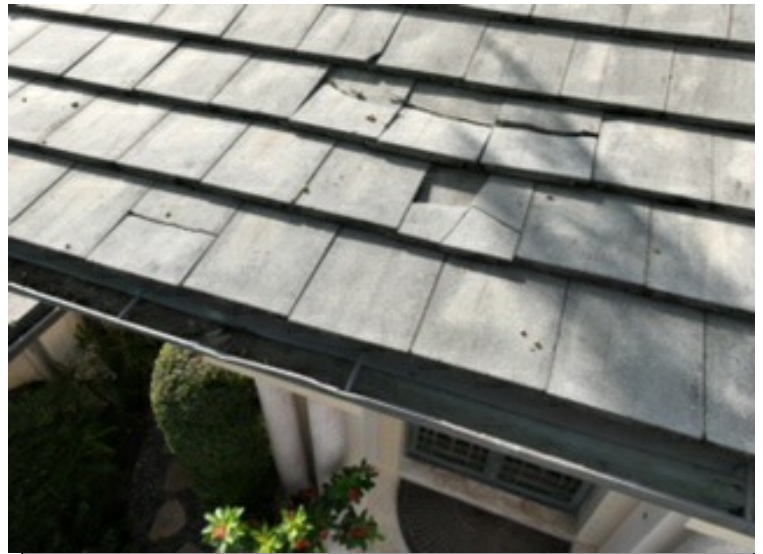
Broken Roof Tiles -

Multiple broken roof tiles were identified throughout the roof system.

Damaged tiles compromise the roof's ability to properly shed water and increase the risk of moisture intrusion beneath the roof covering.

Replacement of damaged tiles is recommended as part of the restoration process.

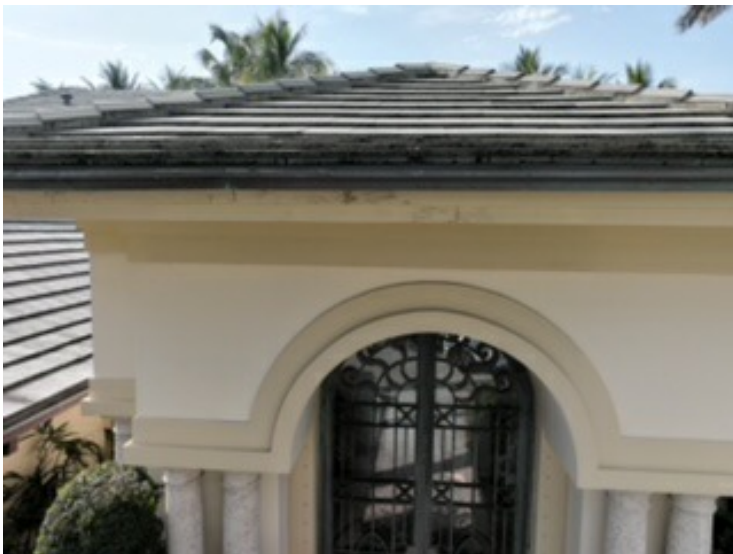
Fascia Deterioration & Moisture Retention

Overhanging palm trees contribute to prolonged moisture exposure in this area by continuing to drip water onto the roof after rainfall events.

Organic debris accumulates beneath the tile system, restricting drainage and trapping moisture.

The deteriorated fascia is indicative of prolonged water intrusion and possible deterioration of the roof deck and plywood components above.

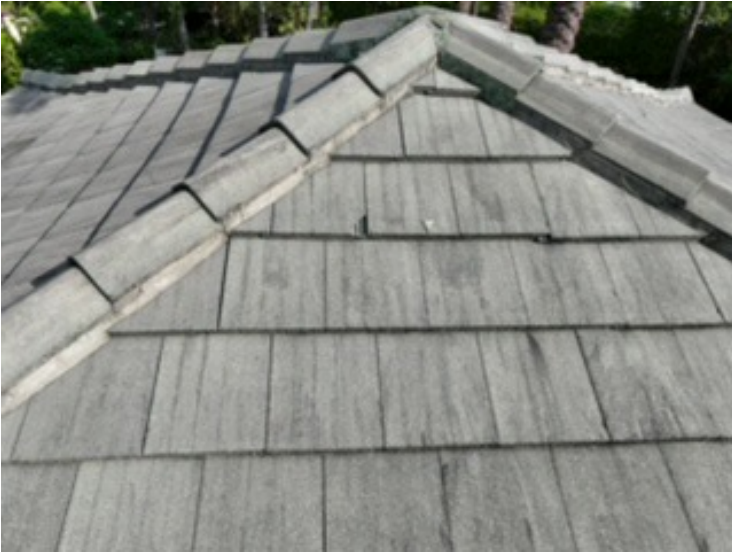
Tile Damage (Upper Roof Section)

Roof tiles exhibit cracking, displacement, and deterioration within this section of roof.

Damaged tiles reduce the roof system’s ability to properly shed water and increase the likelihood of water intrusion into the underlayment system below.

This area requires tile replacement and repair to maintain proper roof performance.

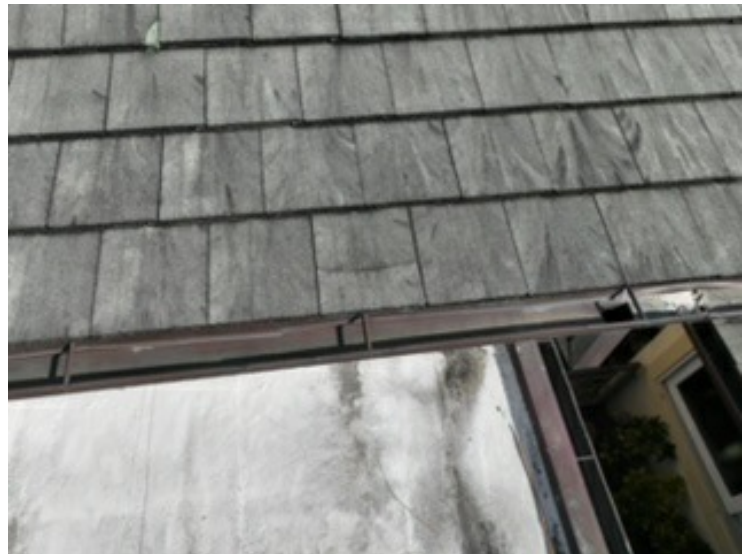
Failing Flashing Condition

Roof-to-wall flashing within this section shows signs of age-related deterioration and failure.

Flashing is a critical waterproofing component that directs water away from transitions and penetrations.

Deficient flashing can allow moisture intrusion beneath the roof covering and should be rebuilt as part of the corrective work.

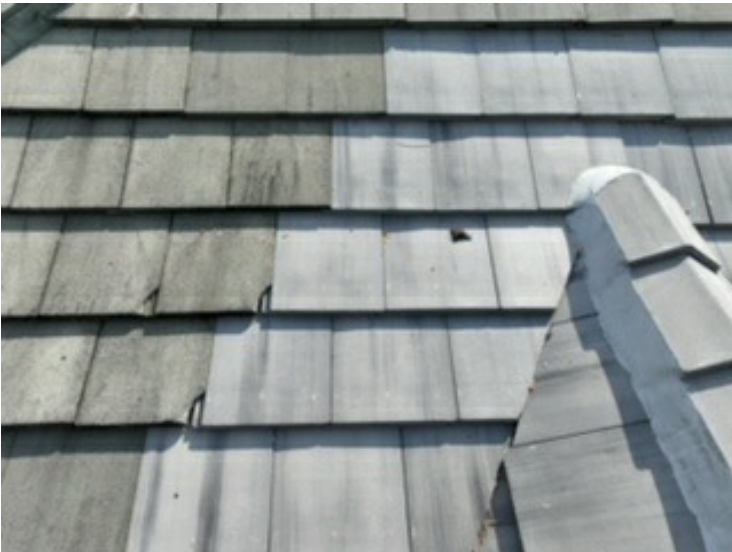
Tile Damage (Field Area)

Additional cracked and damaged roof tiles were observed within the field of the roof.

Broken tiles compromise the integrity of the roof covering and can accelerate deterioration of underlying Components.

Damaged tiles should be replaced and surrounding tiles inspected for proper securement and serviceability.

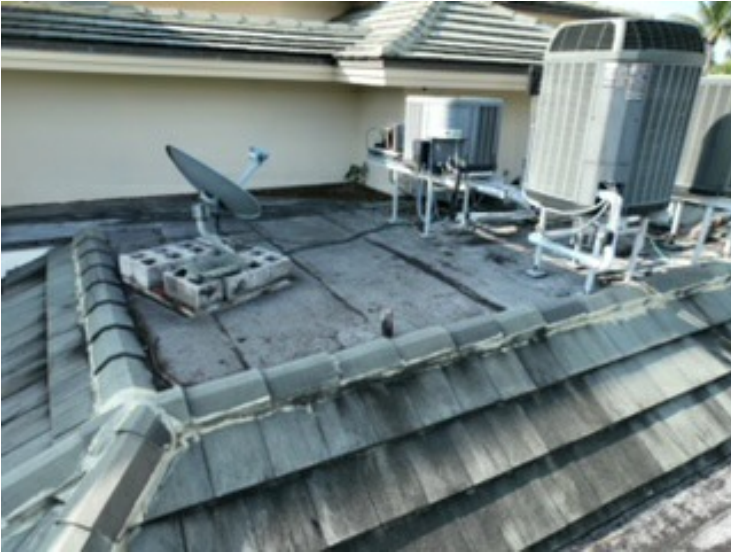
Deteriorated Flat Roof Section

The flat roof section exhibited age-related deterioration at field membranes, flashings, terminations, curbs, and other roof penetrations.

These components are critical waterproofing transition points and showed signs of wear requiring corrective reconstruction to maintain watertight integrity.

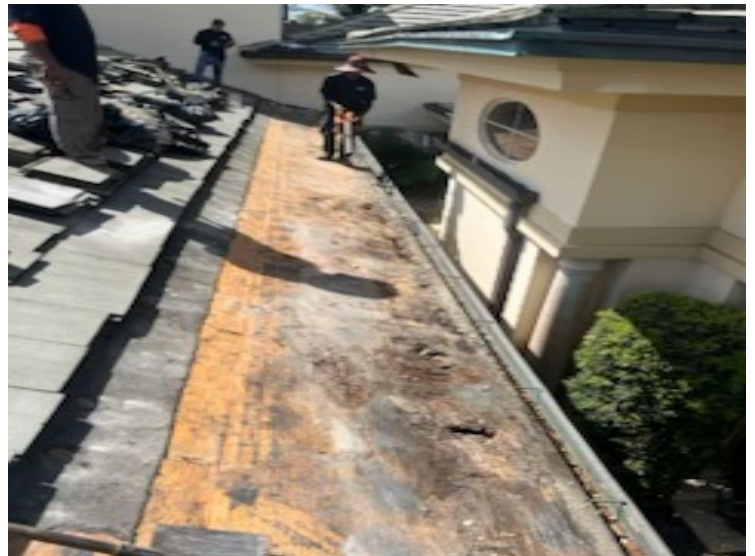
Roof Deck Opened for Repairs

Roofing materials were removed in identified deficiency areas to expose the underlying roof deck.

Compromised plywood sheathing was identified and removed as needed to provide a sound substrate for new roofing system components.
