| Project Owner's Name: | Project Owner's Name:<br>████ Barletta Winds Pt. |
| Project Address:<br>Delray Beach, FL █████ | |

We inspected the areas you requested on 6/24/2026. We discovered some problems that we wanted you to look at. Below are photographs taken during that inspection.

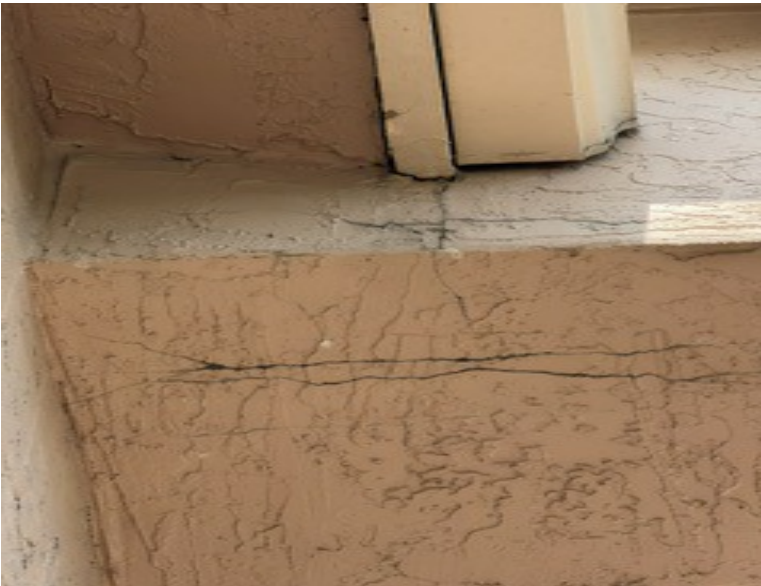
Cracked and deteriorated stucco in this area is consistent with water intrusion from the failing roof assembly above. The roof section should be properly rebuilt to eliminate the source of the leak before repairing the affected stucco and soffit.

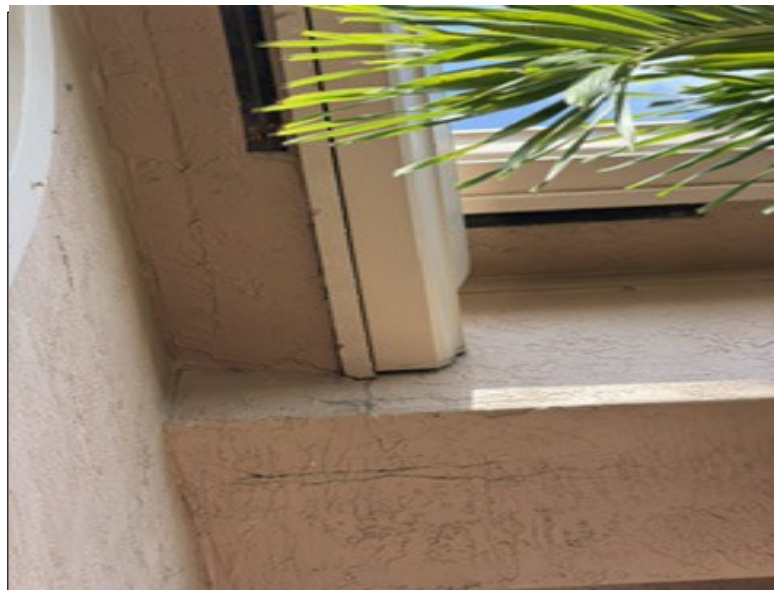
Second view of the same affected area. Cracking and deterioration of the stucco are consistent with ongoing water intrusion from the roof assembly above. The roof section should be properly opened and rebuilt to eliminate the source of moisture before repairing the affected stucco and soffit.

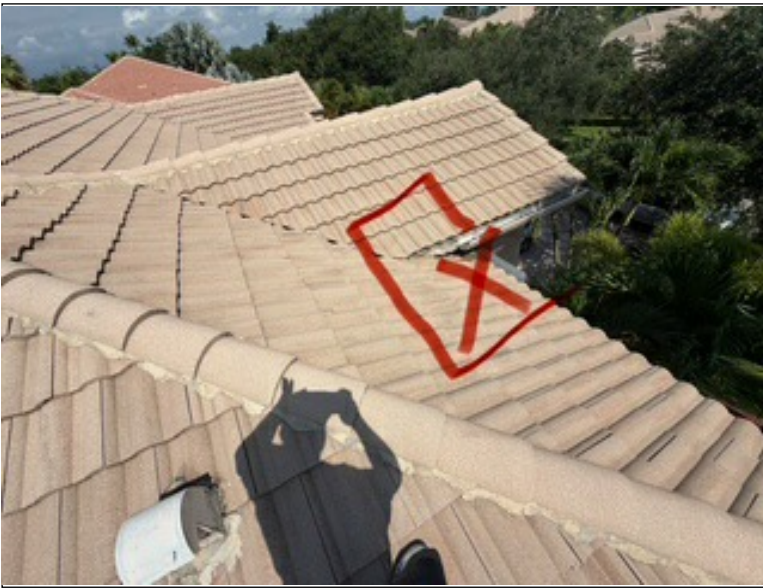
The area outlined in red identifies the failing roof section. This section should be opened, the roof deck inspected for concealed damage, any compromised plywood replaced as needed, and the roofing system properly rebuilt to restore a watertight assembly.

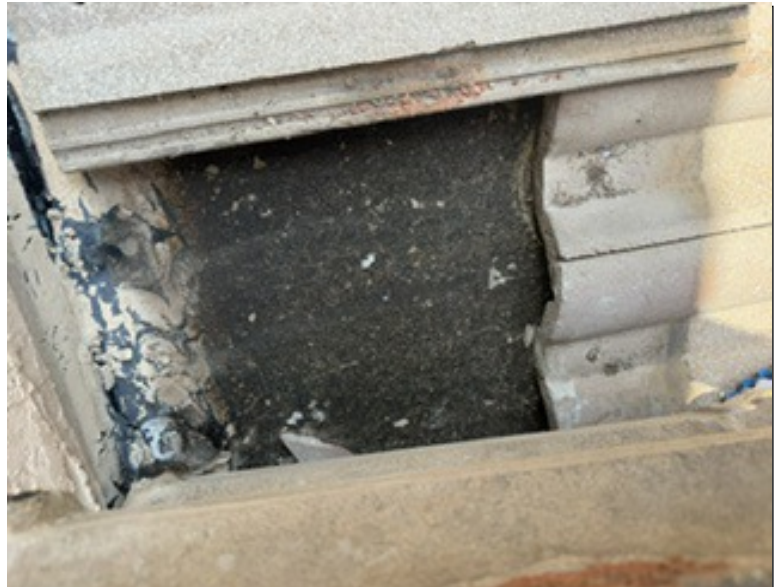
A loose roof tile was removed from a representative section of the roof to inspect and document the condition of the underlying roof tile underlayment. The underlayment in this general field area appears to be in satisfactory condition, with an estimated remaining service life of approximately 25%. This finding indicates that the general sections of the roof remain serviceable, while the high water flow areas are experiencing localized failure and require corrective rebuilding.

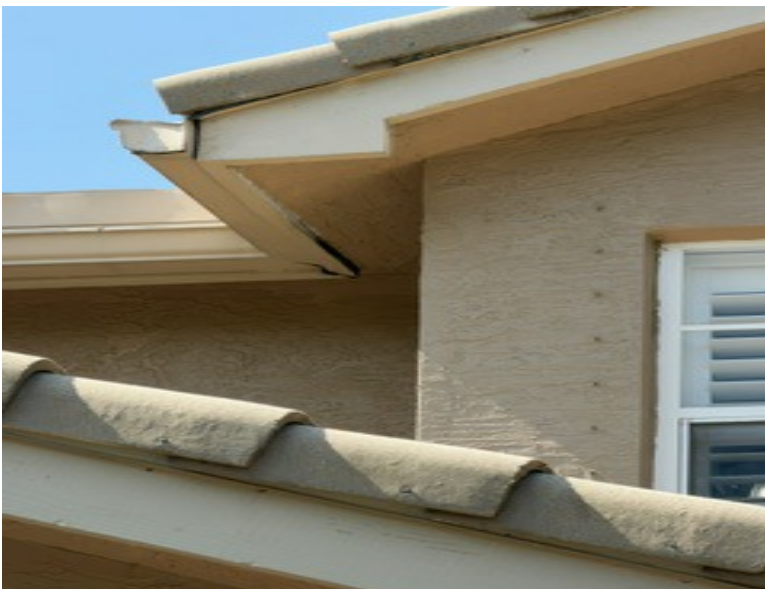
Staining and deterioration of the fascia board were observed below the roof valley. The location and condition are consistent with prolonged water intrusion originating from the failing high water flow area above. The roof section should be properly opened and rebuilt to eliminate the source of the leak, with repair or replacement of the affected fascia as needed.

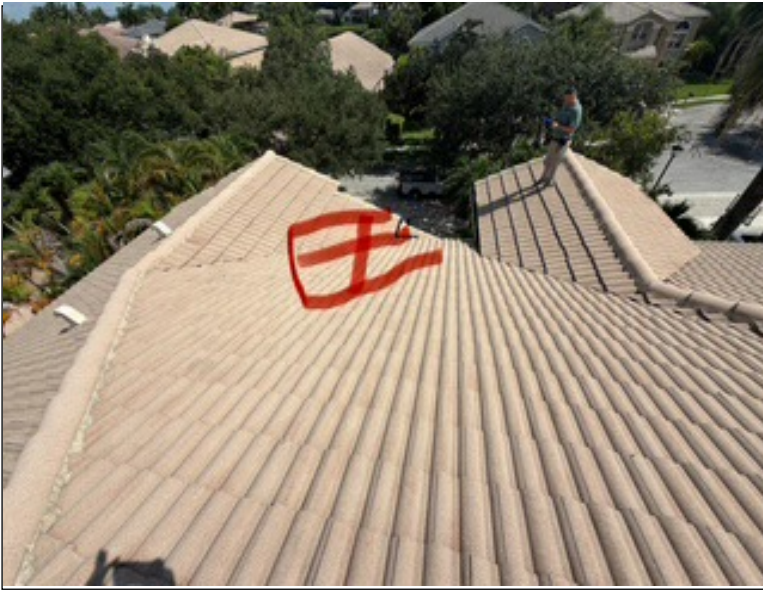
The area outlined in red identifies the failing roof section. This section should be opened, the roof deck inspected for concealed damage, any compromised plywood replaced as needed, and the roofing system properly rebuilt to restore a watertight assembly.

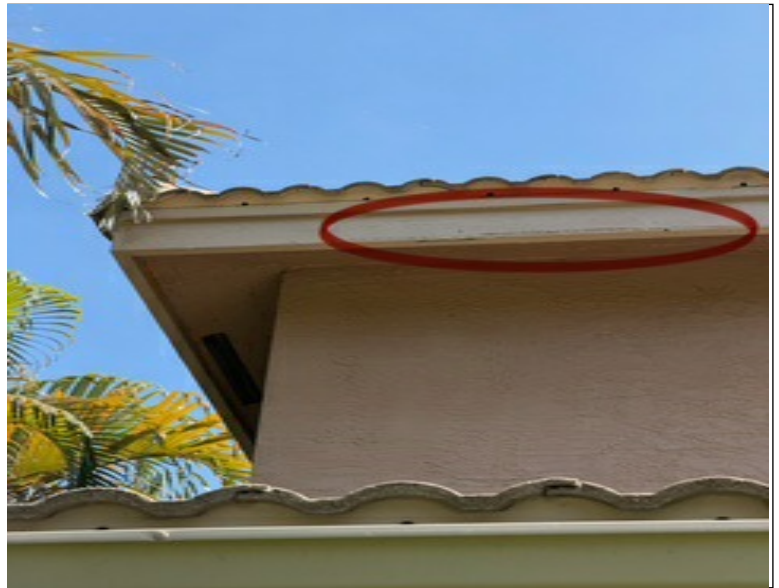
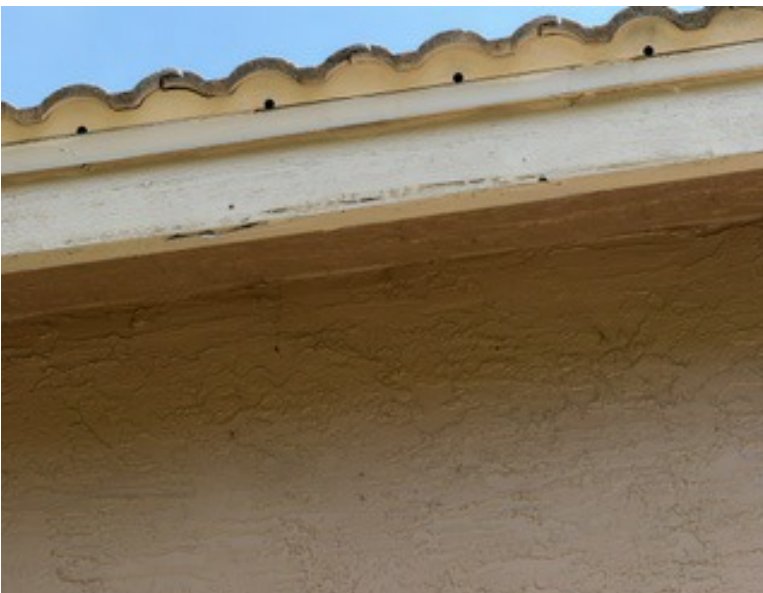
An area of exposed fascia board was observed and is in need of repair. This section should be properly filled, sealed, and painted to help prevent further water intrusion, deterioration, and damage.

Area pictured above.

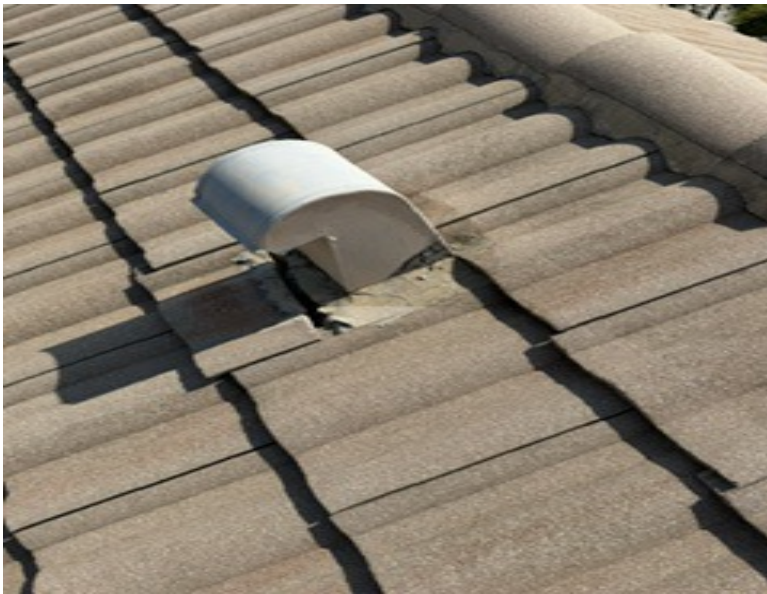
All vents should have new roof tile mortar installed around vents, as well as prime and paint vents to stop rust.

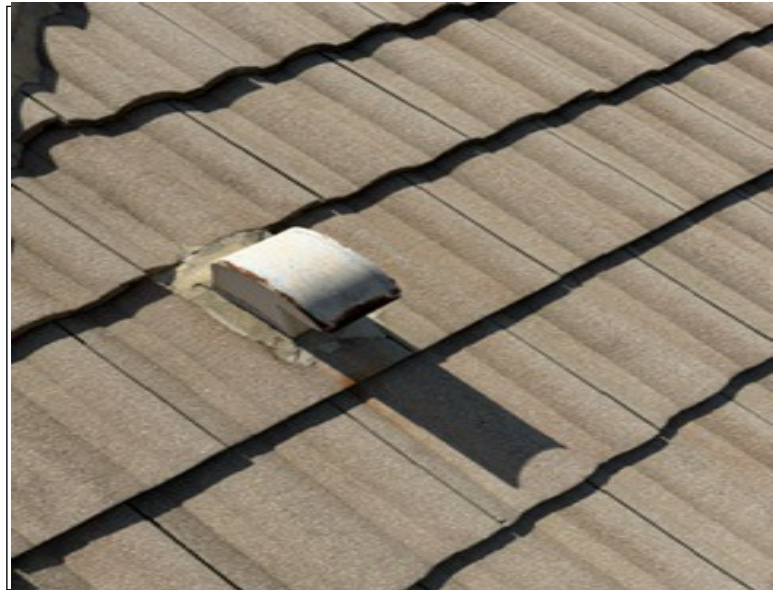
All vents should have new roof tile mortar installed around vents, as well as prime and paint vents to stop rust.

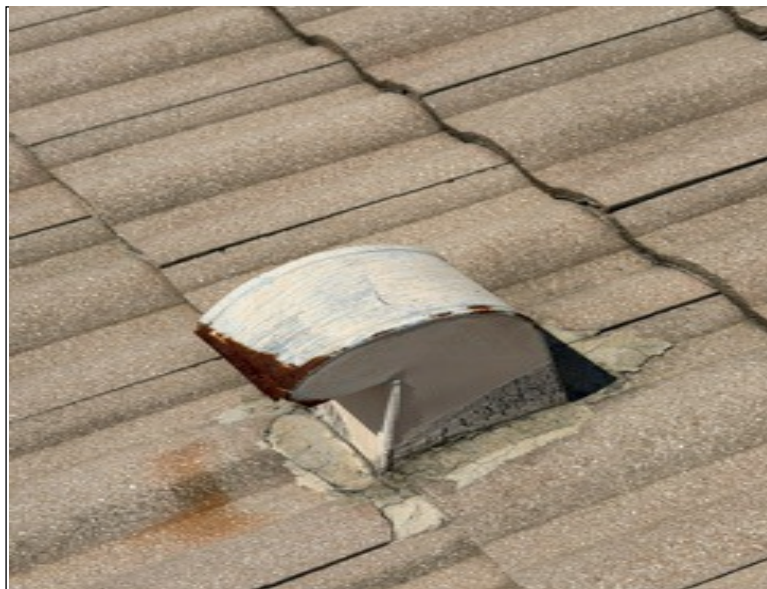
All vents should have new roof tile mortar installed around vents, as well as prime and paint vents to stop rust.

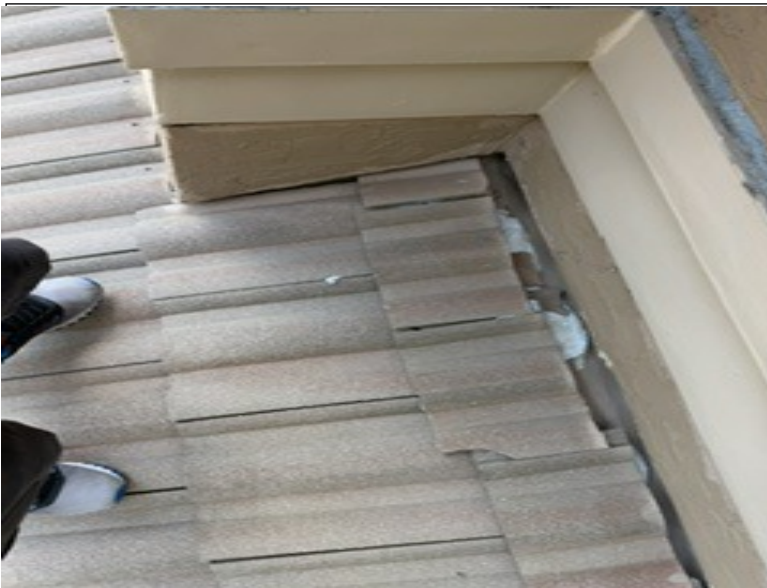
slipped and loose tiles across various sections of roof that need to be refastened.

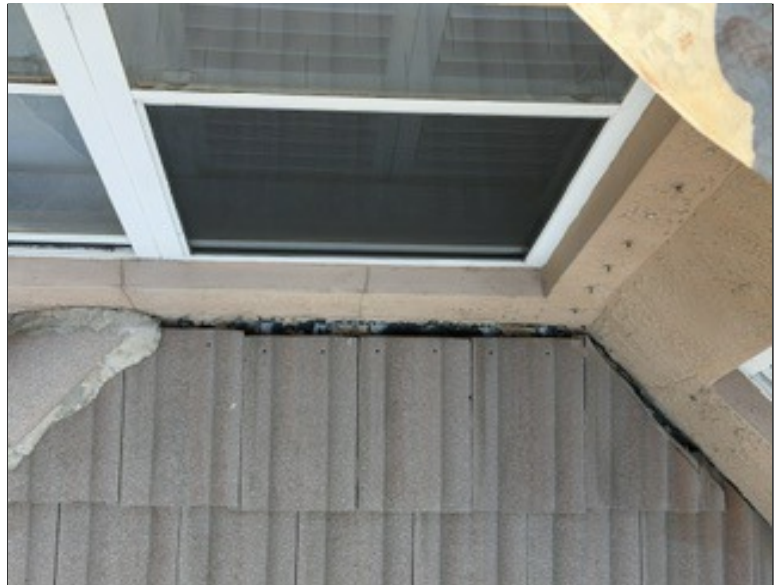
slipped and loose tiles across various sections of roof that need to be refastened.

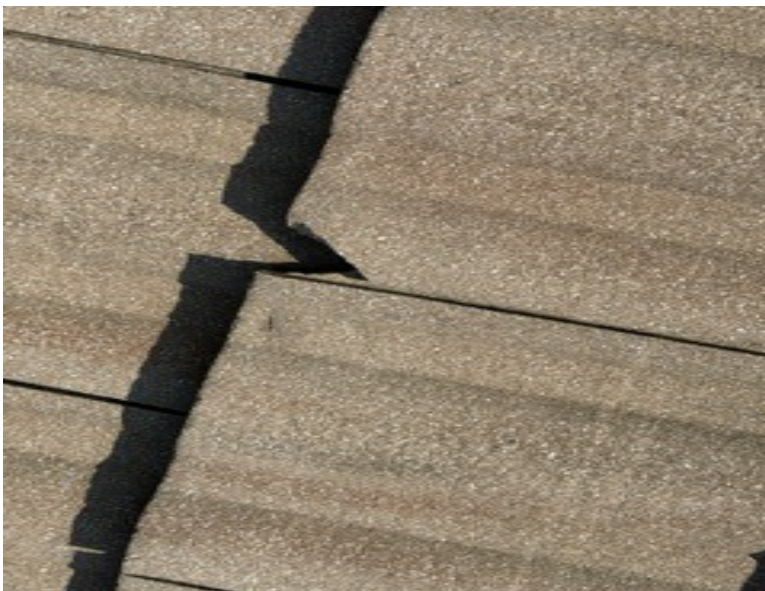
Various chipped roof tiles were observed across the roof system. The chipped areas should be properly filled with roof tile mortar as needed to help protect the tiles from further deterioration and maintain the integrity of the roof system.

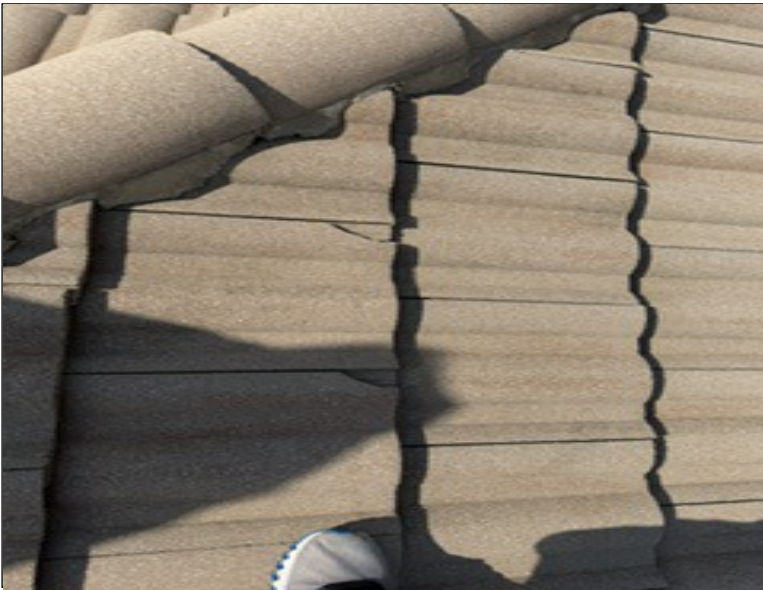
Various chipped roof tiles were observed across the roof system. The chipped areas should be properly filled with roof tile mortar as needed to help protect the tiles from further deterioration and maintain the integrity of the roof system.

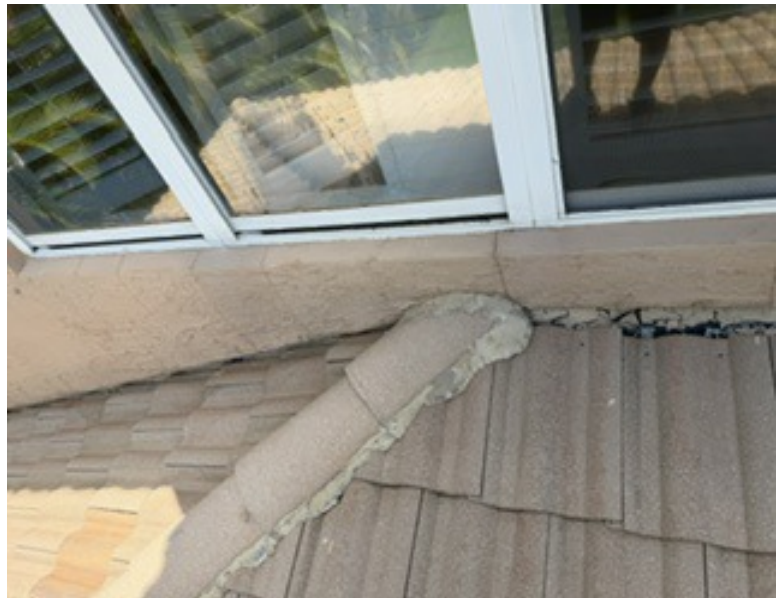
Cracks were observed along the stucco wall in this section, allowing water intrusion into the structure. The affected stucco should be properly repaired, sealed, and painted to match the existing finish to help prevent further moisture intrusion and deterioration.

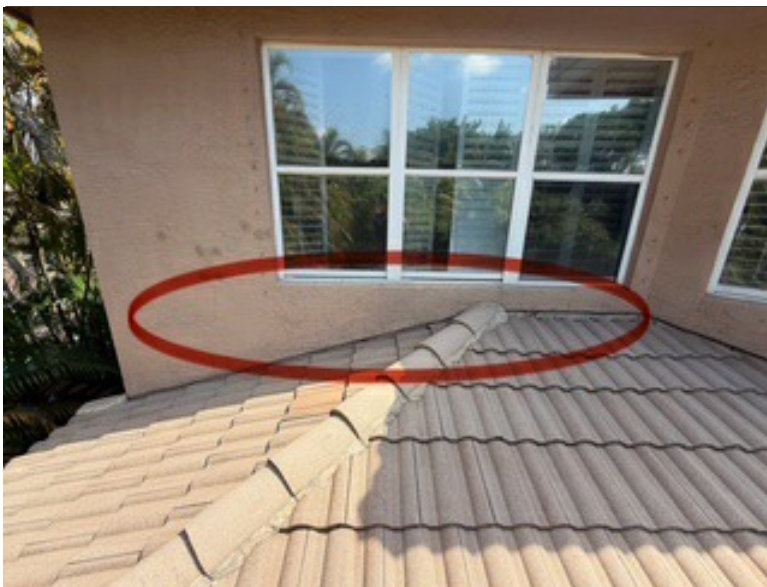
Cracks were observed along the stucco wall in this section, allowing water intrusion into the structure. The affected stucco should be properly repaired, sealed, and painted to match the existing finish to help prevent further moisture intrusion and deterioration.
