## 5 YEAR ROOF CERTIFICATION & REMAINING USEFUL LIFE ASSESSMENT

| Owner's Name:<br>Delray Beach Ultra Luxury Estate | | Property Address:<br>[REDACTED] Delray Beach, FL [REDACTED] | | Roof Type:<br>Concrete Tile | | Approx. Roof Age<br>YEARS | |
| INSPECTION DATE<br>07/22/2026 | CERTIFICATION NUMBER<br>MMR- 07222026 | DATE OF EXPIRATION<br>07/22/2031 | INSPECTOR LICENSE NO.<br>CCC1331721 | INSPECTOR NAME<br>Mike McGilvary | | | |

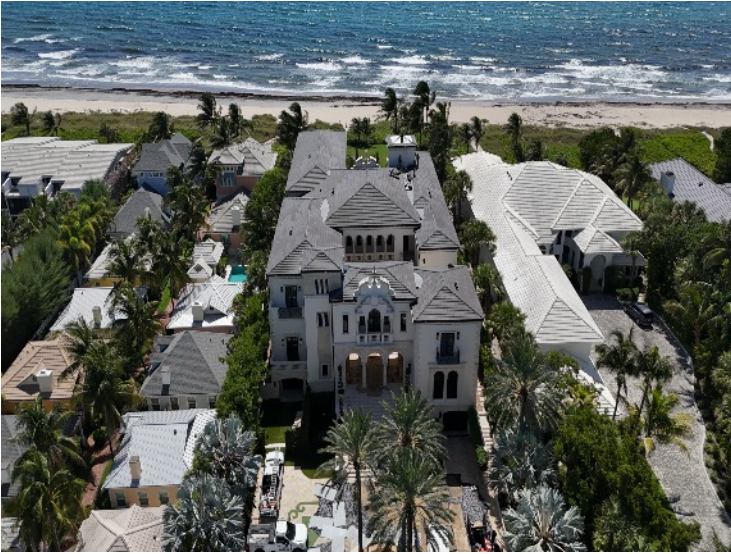
This aerial photograph provides an overall view of the concrete tile roofing system on an ultra-luxury oceanfront estate in Delray Beach, Florida.

The image documents the roof's multiple elevations, hips, ridges, valleys, and architectural transitions prior to corrective work.

While the roof appeared generally well maintained from this perspective, a detailed inspection identified a localized area requiring reconstruction. This photograph establishes the overall condition of the roofing system and serves as the baseline image for this roof certification report.

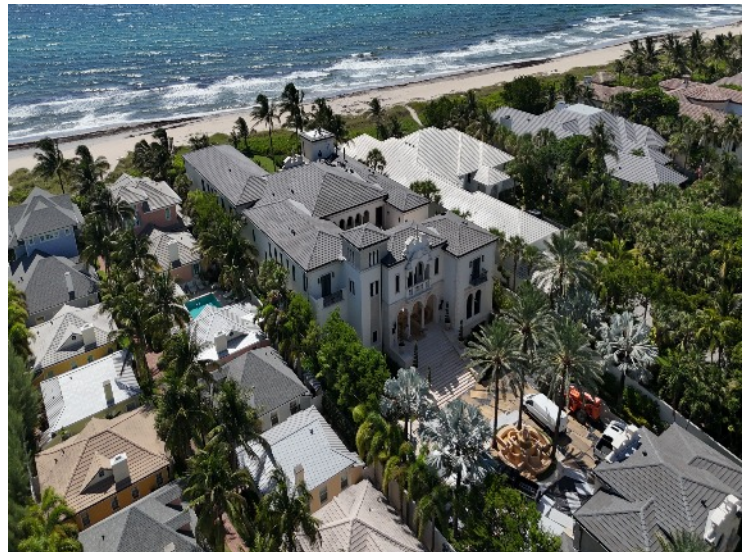
This aerial photograph documents the roof from an angled perspective, illustrating the complexity of the concrete tile roofing system and its direct oceanfront exposure.

The image captures multiple roof elevations, valleys, hips, ridges, and architectural transitions that were evaluated during the inspection.

This perspective assisted in identifying the specific area requiring corrective reconstruction while documenting the overall condition of the remaining roof system prior to repairs.

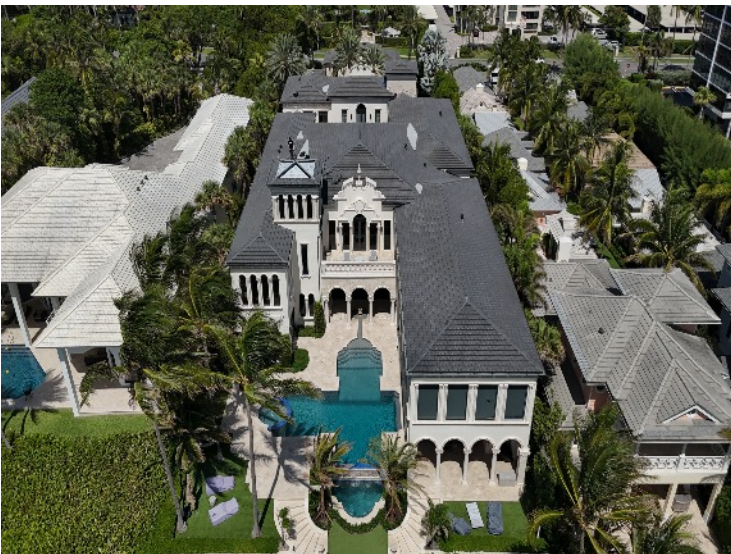
This aerial photograph documents the rear elevation of the residence, illustrating the complexity of the concrete tile roofing system and multiple intersecting roof planes. The inspection evaluated the hips, ridges, valleys, roof-to-wall transitions, and drainage paths throughout this section.

This perspective provided additional documentation of the roof's overall condition while assisting in locating and evaluating the area requiring corrective reconstruction.

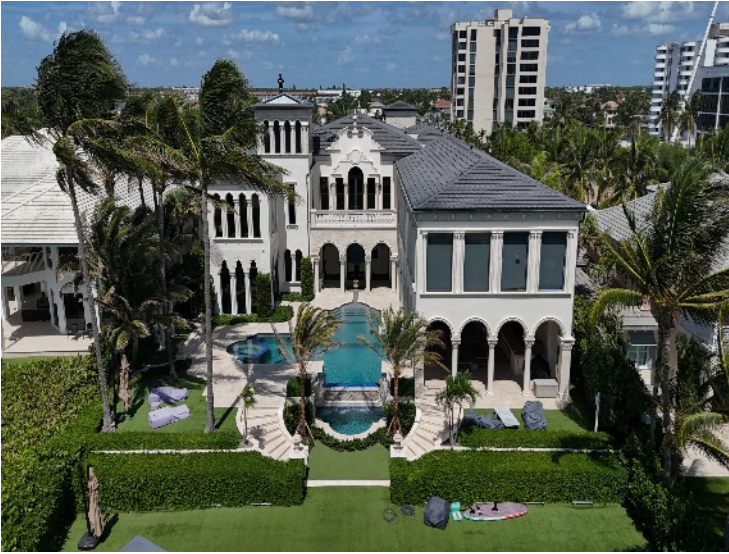
This rear elevation photograph provides a closer view of the concrete tile roofing system from the ocean-facing side of the residence.

The image documents the overall roof condition, architectural features, and multiple roof transitions evaluated during the inspection.

This perspective further confirms the complexity of the roofing system and served as part of the comprehensive documentation used to identify the localized area requiring corrective reconstruction.

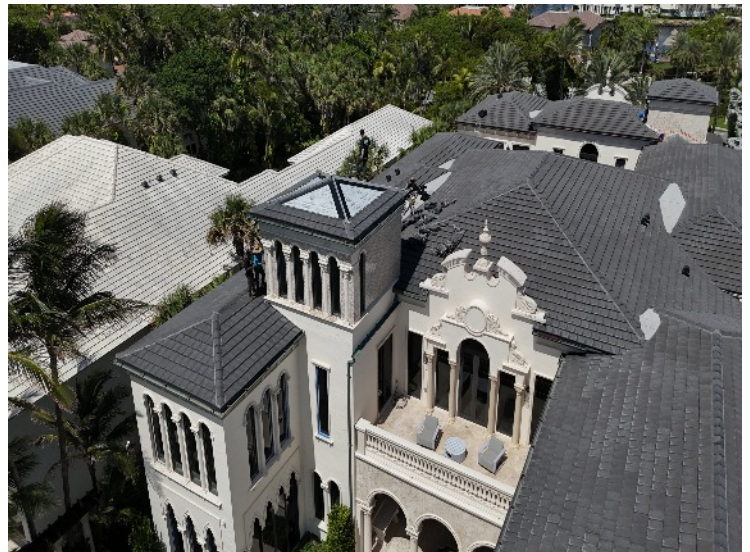
This photograph documents the specific section of the concrete tile roofing system where a localized failure was identified during the inspection.

Although the roof was approximately two years old, this area required corrective reconstruction due to deficiencies within the roofing assembly.

The affected section was carefully opened, the underlying components were inspected and rebuilt as needed, and the roof was restored using proper roofing methods while preserving the surrounding serviceable roof system.

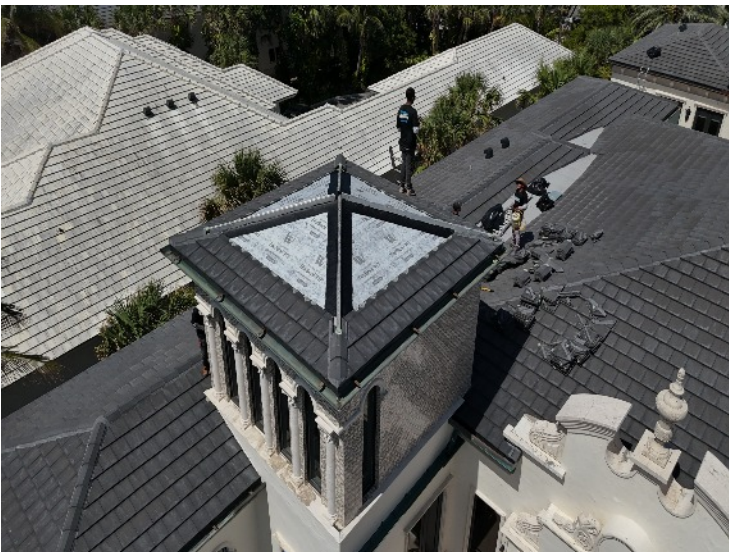
This close-up photograph documents the localized section of roof that was opened to facilitate corrective reconstruction.

The image shows the exposed underlayment, removed concrete roof tiles, and active reconstruction process following identification of the roofing deficiency. All work was performed in a controlled manner to restore the affected area while preserving the surrounding serviceable roof system.

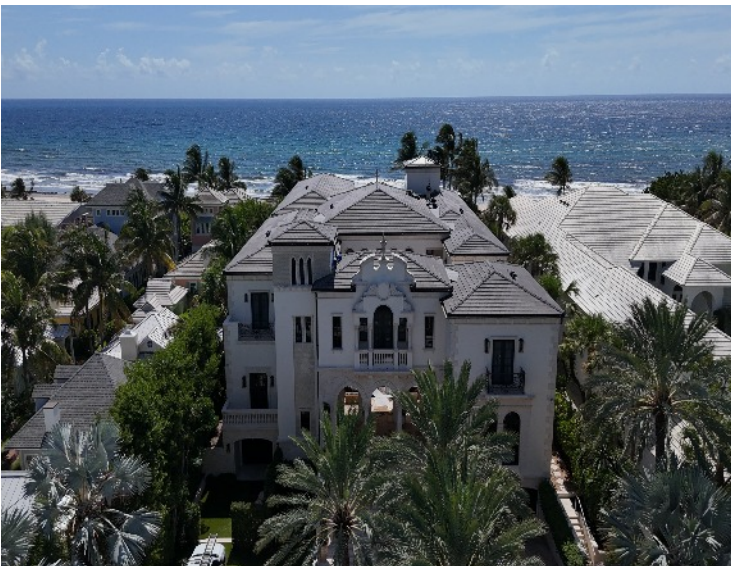
This final aerial photograph documents the completed roof reconstruction and overall condition of the concrete tile roofing system following repairs.

The affected section has been professionally rebuilt, the original roof tiles reinstalled, and the roofing system restored to a serviceable condition. Based upon our inspection and the corrective work performed, the roof qualifies for certification and is considered to be in satisfactory condition at the time of this report. This image serves as the final documentation of a successfully completed inspection, reconstruction, and roof certification for this architecturally significant oceanfront residence.
