## 5 YEAR ROOF CERTIFICATION & REMAINING USEFUL LIFE ASSESSMENT

| Contact Email: | Contact Phone #1: | Contact Phone #2: | Roof Type:<br>Concrete Tile | Approx. Roof Age<br>25 YEARS |
| INSPECTION DATE<br>7/14/2026 | CERTIFICATION NUMBER | DATE OF EXPIRATION<br>07/14/2031 | INSPECTOR LICENSE NO.<br>CCC1331721 | INSPECTOR NAME<br>Mike McGilvary |

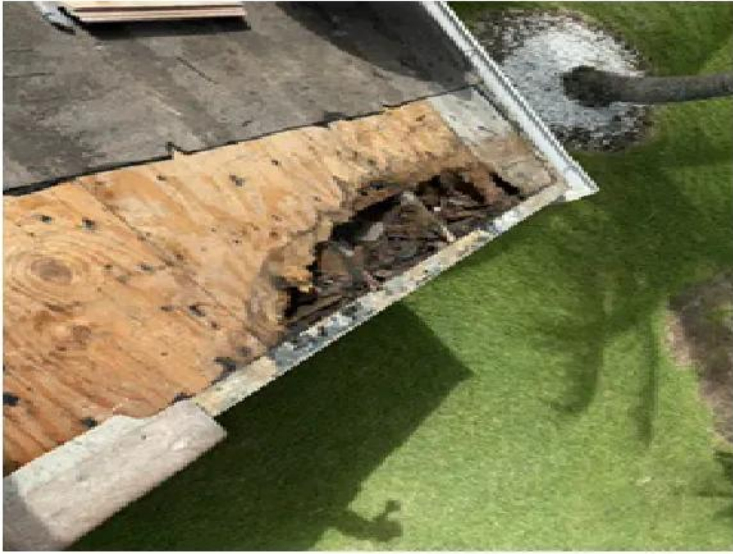
### Area of Deterioration – Roof Deck Failure

During the inspection, this section of the roof exhibited advanced deterioration. Dirty water staining was visible on the fascia board below, indicating prolonged moisture intrusion and suggesting compromised roof sheathing above.

Upon removal of the existing roofing materials, our findings confirmed the cause. The roof decking in this area had sustained significant wood rot and structural deterioration due to long-term water infiltration, requiring removal and replacement of all compromised sheathing before the roofing system could be properly restored.

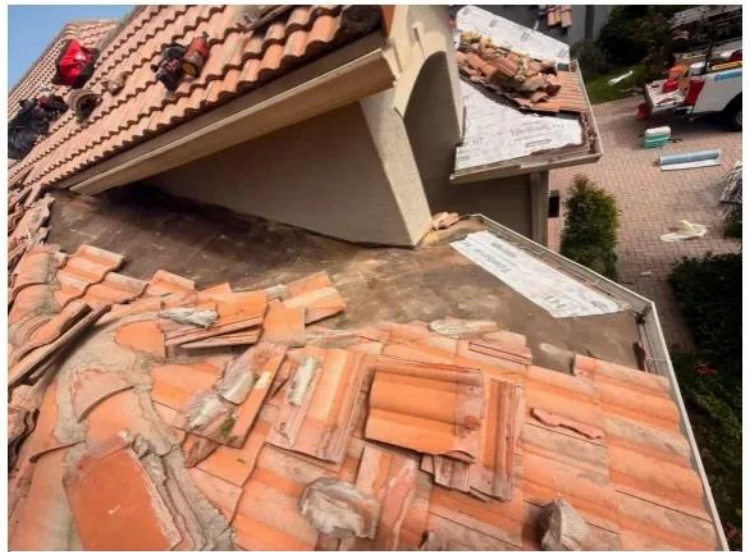
### High Water-Flow Area – Prior Repair Failure

This high water-flow section of the roof exhibited visible signs of long-term water intrusion. Dirty water staining on the fascia board below indicated moisture infiltration and suggested deteriorated roof decking above. Upon further evaluation, these indicators proved to be accurate, with significant wood rot discovered beneath the roofing system.

Also visible is evidence of a previous repair attempt.

While prior repairs had been made, they did not address the underlying deterioration of the roof deck, allowing water intrusion to continue.

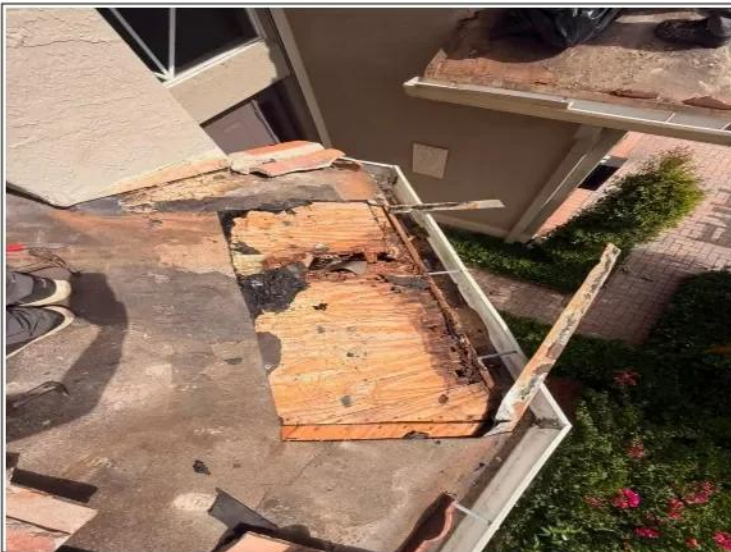
### Hidden Damage Discovered Beneath Previous Repair

Once the previous repair was removed, extensive hidden wood rot was uncovered beneath the roofing system. The earlier repair addressed only the surface symptoms and failed to identify or replace the deteriorated roof decking, allowing moisture intrusion to continue unchecked.

This photo demonstrates why a condition-based inspection is critical. The dirty water staining observed on the fascia board accurately indicated concealed structural deterioration that was not visible from the exterior. All compromised sheathing was removed and replaced with new code-compliant plywood before installation of the new underlayment and restoration of the roofing system.

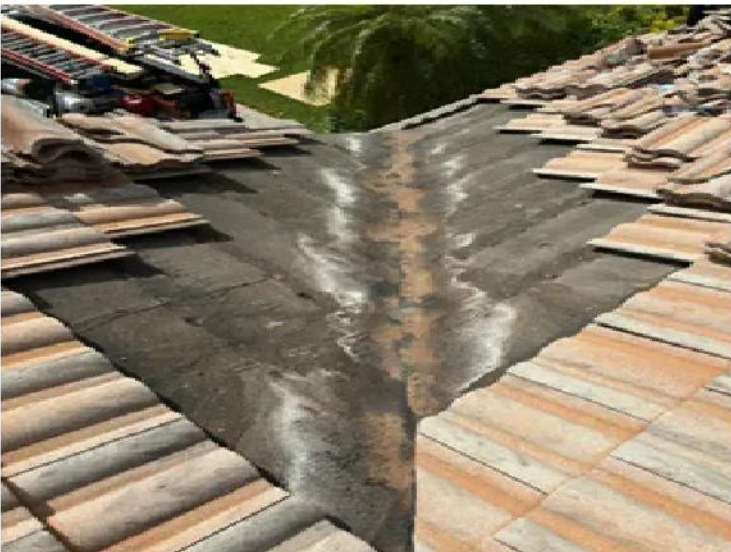
### Valley Area Opened for Inspection

This valley was opened for inspection due to concentrated water flow. As shown, the deterioration is isolated to the center of the valley where the majority of water drains. The surrounding roof underlayment remains in structurally sound condition, demonstrating that this is a localized wear area rather than a roof-wide failure.

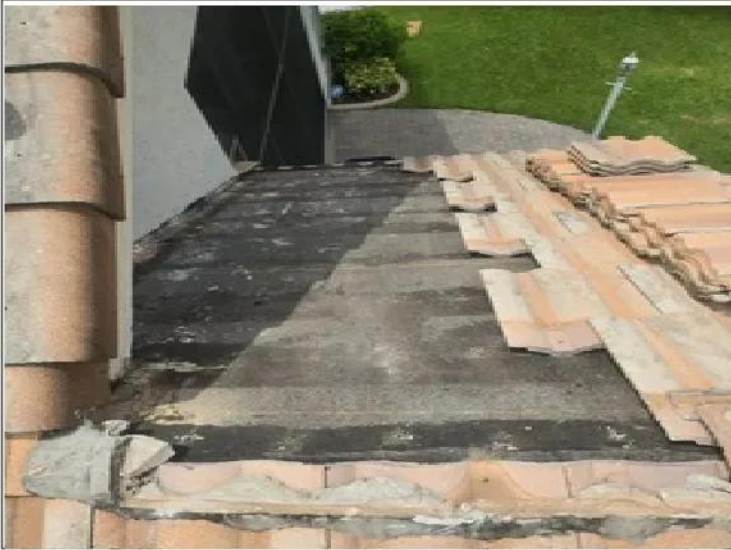
### Additional High Water-Flow Area

Another high water-flow section was opened for inspection due to signs of deterioration. As shown, the wear is concentrated within this drainage path, while the surrounding roof underlayment remains in serviceable condition. This confirms a localized repair was appropriate, addressing the failed area while preserving the structurally sound portions of the existing roof system.

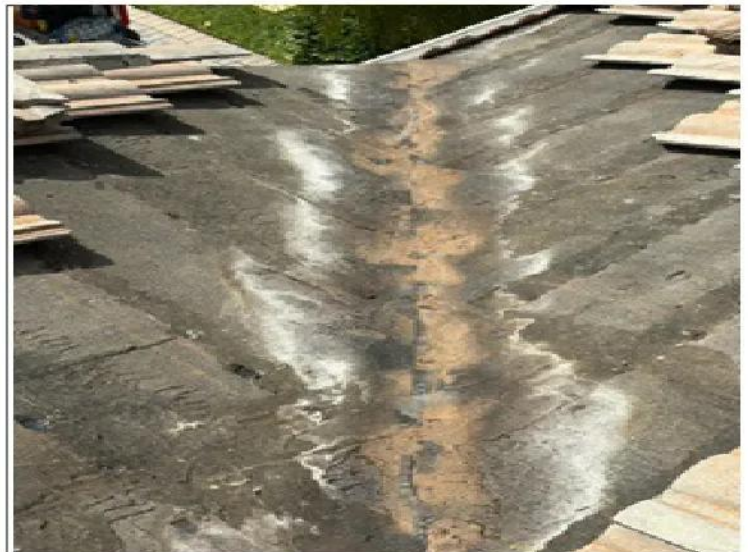
### Valley Wear Pattern – Close-Up

Close-up of the valley showing wear isolated to the center where the highest volume of water flows. The surrounding underlayment remains in serviceable condition, confirming this is localized deterioration caused by concentrated water flow rather than a roof-wide failure.

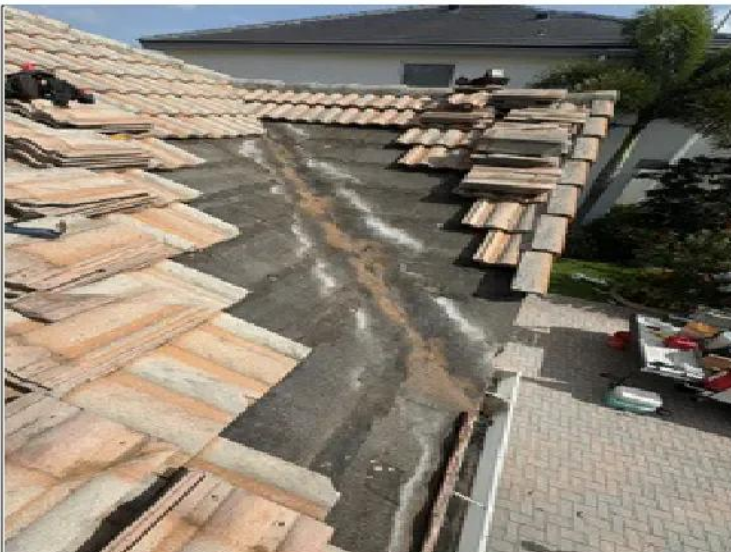
### Additional Valley Area

Another valley was opened for inspection, revealing wear isolated to the center of the drainage path where the highest volume of water flows. The surrounding roof underlayment remains in serviceable condition, confirming this is a localized deterioration requiring repair rather than a full roof replacement.

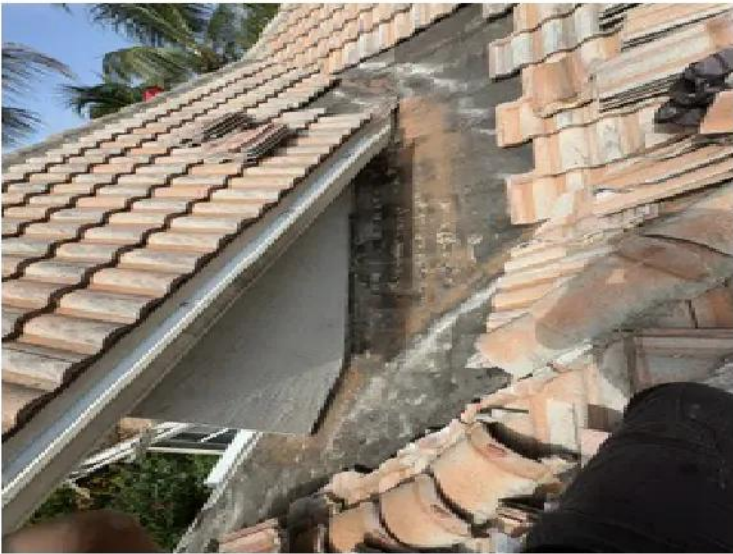
### Localized Valley Wear

This valley clearly demonstrates where the roof has reached the end of its service life.

The wear is confined to the center of the valley—the primary water-flow path—while the surrounding underlayment remains in serviceable condition.

The roof is effectively showing where repair is needed, supporting a targeted valley rebuild rather than unnecessary replacement of the entire roof system.

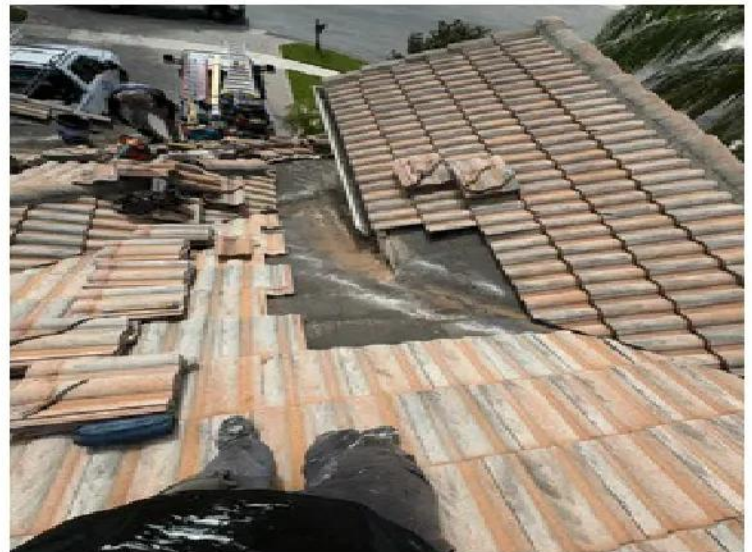
### Localized Valley Wear – Alternate View

Alternate view of the same valley showing deterioration isolated to the primary water-flow path. The surrounding roof underlayment remains in serviceable condition, confirming this is a localized repair area and demonstrating that the roof can be preserved through targeted repairs rather than full replacement.

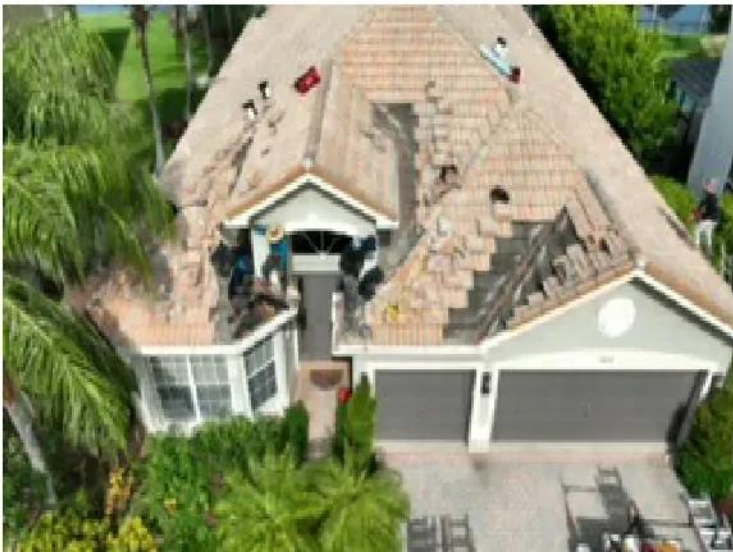
### Aerial Overview of Repair Areas

Aerial view identifying the localized repair areas addressed during this project. The repairs were concentrated in high water-flow valleys and drainage transitions where wear had occurred, while the remaining roof system remained in serviceable condition.

This illustrates how targeted, condition-based repairs can preserve the existing roof without requiring a full replacement.

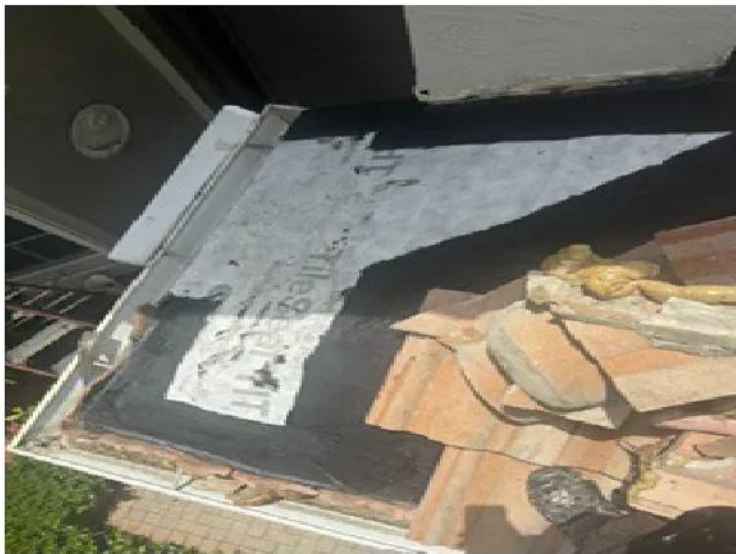
his high water-flow roof section was fully rebuilt after localized deterioration was identified.

New roof tile underlayment was installed to restore a continuous, watertight roofing system.

The area is now structurally sound and ready for reinstallation of the existing roof tiles in their original placement.

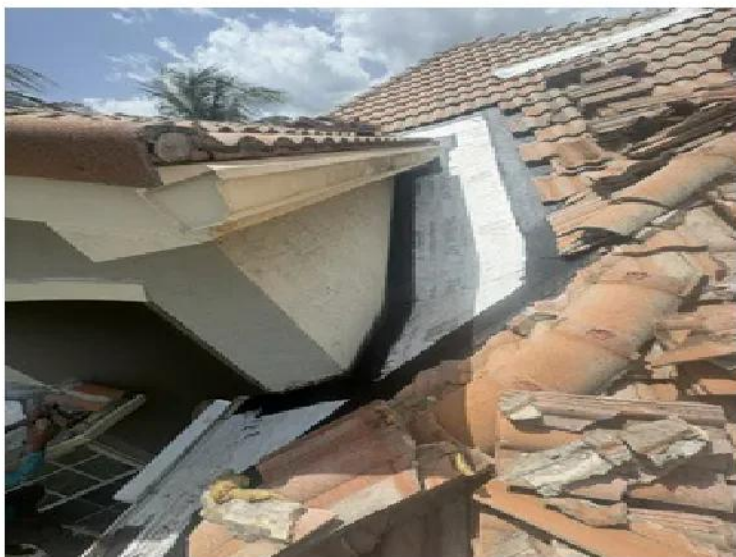
### Large High Water-Flow Area Rebuilt

This larger high water-flow section was fully rebuilt after localized deterioration was identified.

New roof tile underlayment was installed, restoring the area to a structurally sound, watertight condition. The section is now ready for reinstallation of the existing roof tiles in their original placement.

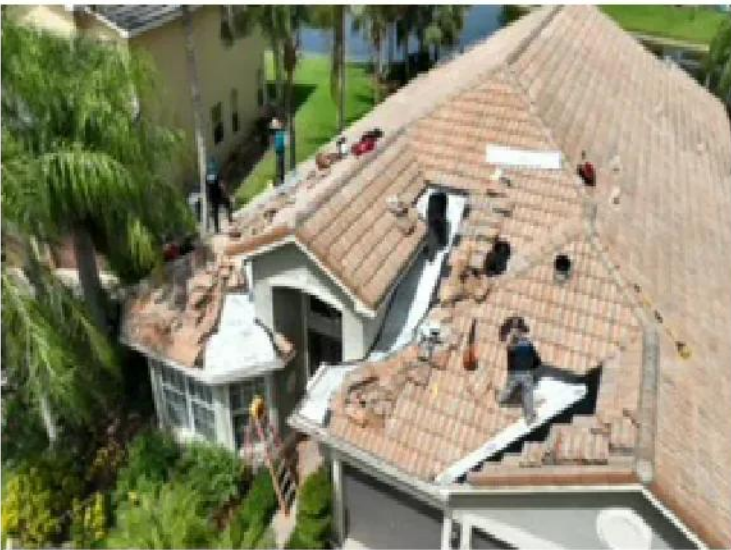
### Aerial Overview of Rebuilt Areas

This aerial view illustrates the overall scope of the project, highlighting the multiple localized repair areas completed throughout the roof.

The repairs were strategically concentrated in high water-flow valleys and drainage transitions where deterioration had occurred, preserving the structurally sound portions of the existing roof and demonstrating that targeted, condition-based repairs were the appropriate solution rather than full roof replacement.
