## 5 YEAR ROOF CERTIFICATION & REMAINING USEFUL LIFE ASSESSMENT

| Owner's Name: | | Property Address: | | Jupiter, FL 33469 | |

## PHOTO EXHIBIT ONE (1) – SUPPORTING DOCUMENTATION

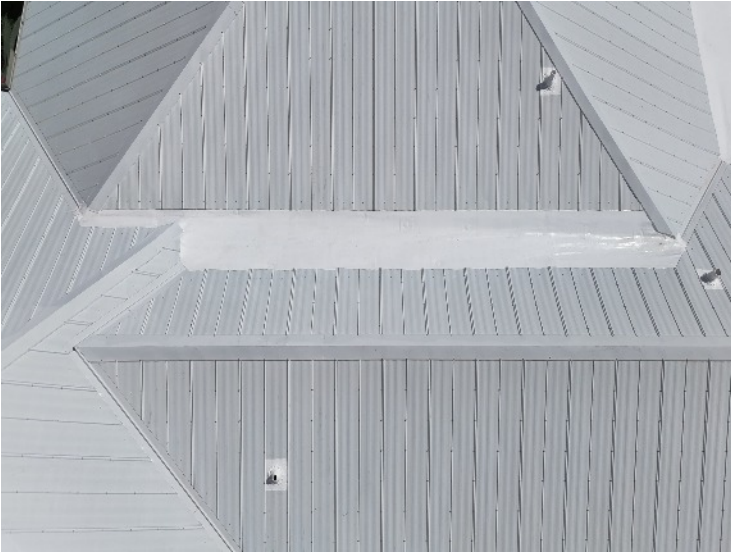
Photo 1 –

### Restored Flat Roof Section

This aerial view shows one of the completed low-slope roof restoration areas adjacent to the sloped metal roofing system. The flat roof surface was cleaned, prepared, sealed at perimeter and transition areas, and finished with a commercial-grade silicone coating. The completed restoration provides a continuous protective surface over the previously weathered membrane area.

The visible roof-to-metal transition points appear sealed and integrated with the adjacent metal roof system at the time of final inspection.

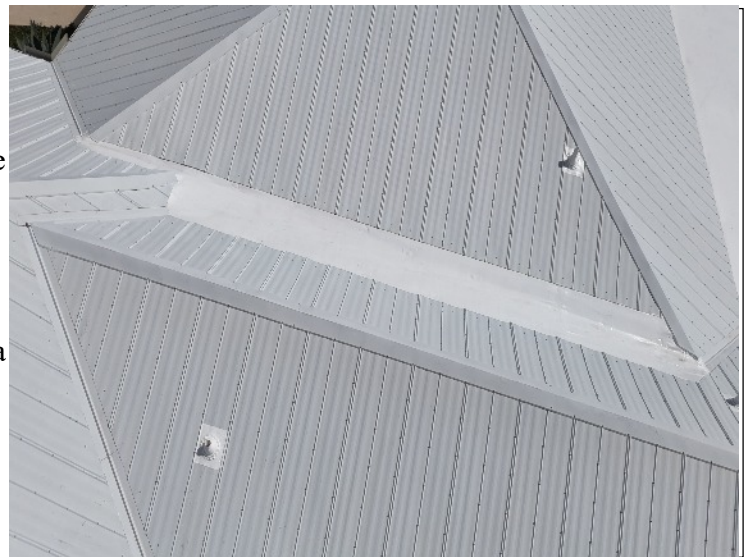
Photo 2 –

### Completed Flat Roof Restoration

This aerial view shows the completed restoration of the secondary flat roof section located between surrounding sloped metal roof planes. The membrane surface was cleaned and prepared before sealant was applied at seams, laps, perimeter areas, and transition points. A final commercial-grade silicone coating was applied across the flat roof surface. The completed area appears uniform and serviceable, helping protect the roof system against water intrusion at the time of inspection.

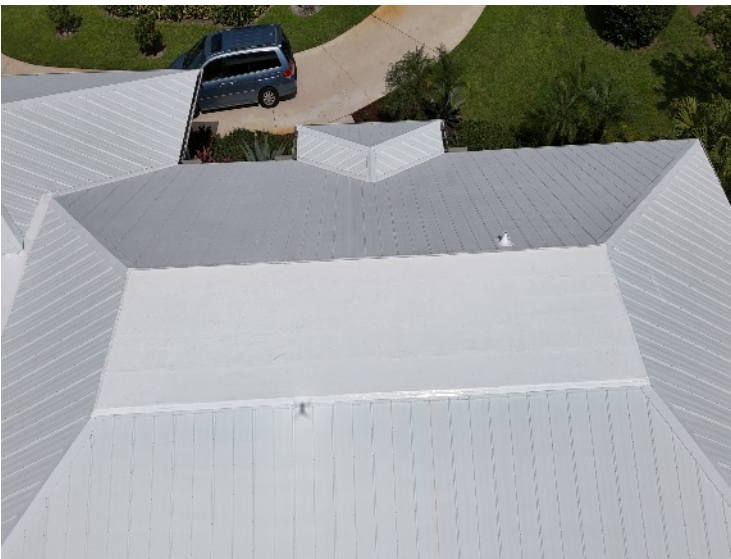
Photo 3 –

### Overall Roof System Overview

This overhead aerial view documents the overall roof configuration, including the main sloped metal roofing system and the two secondary low-slope roof sections restored under the completed repair scope. The photo shows the relationship between the metal roof planes and the flat roof areas where restoration work was performed. The documented work included surface preparation, sealing of seams, laps, penetrations, perimeter conditions, and roof-to-metal transition points to support continued serviceable roof performance.

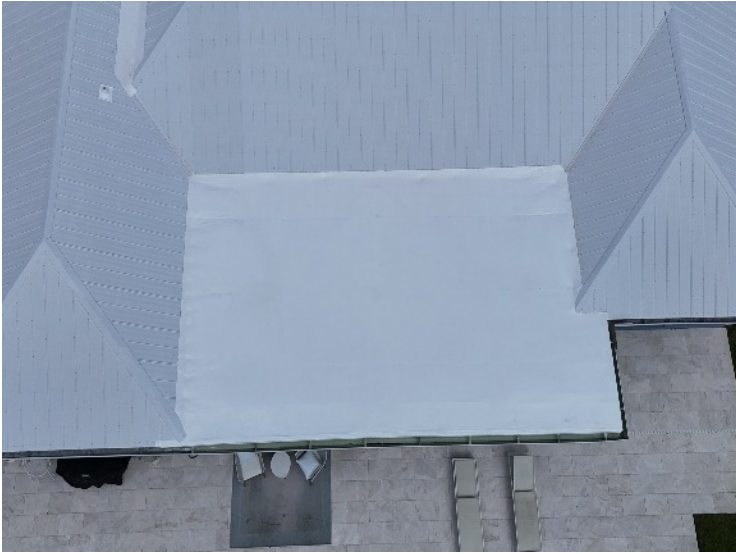
Photo 4 –

### Sealed Metal Roof Transition

This close aerial view shows a completed roof transition where sloped metal roofing meets an adjacent roof section. The transition area was cleaned, prepared, and sealed as part of the restoration scope to address potential water-entry points. Sealant was applied along the connection detail to create a continuous watertight condition between roof systems. The visible transition treatment appears intact and serviceable at the time of final inspection, with no open gaps observed in the accessible view.

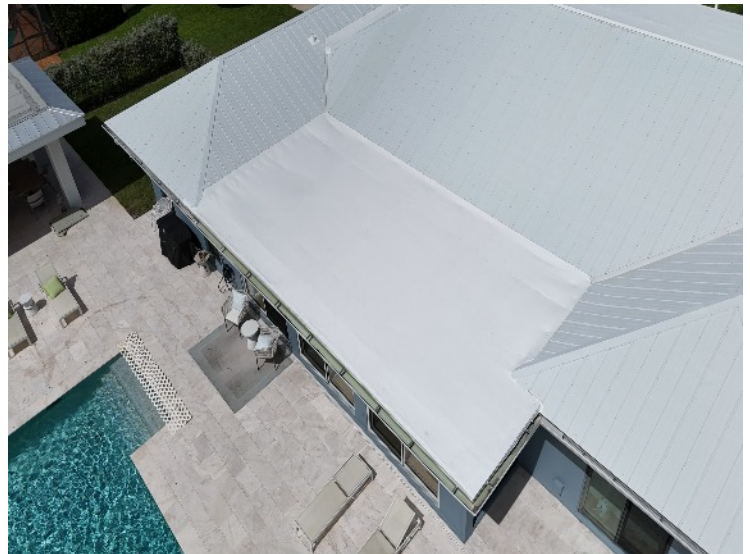
Photo 5 –

### Silicone-Coated Flat Roof Area

This overhead aerial view shows the completed silicone-coated surface of the restored low-slope roof area. The flat roof was pressure washed and prepared before sealing work was completed at seams, laps, perimeter edges, and transition locations adjoining the metal roof. A final commercial-grade silicone coating was then applied to the roof surface. The completed coating creates a continuous protective layer intended to improve water resistance and support the continued serviceability of this roof section.

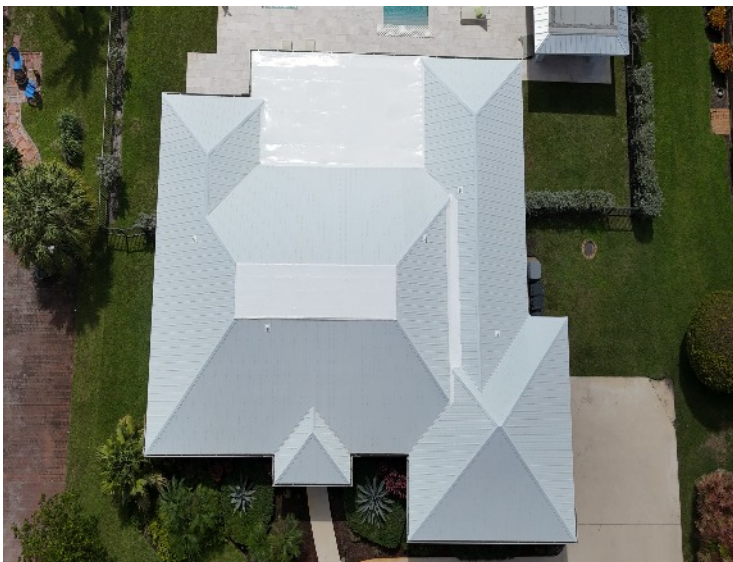
Photo 6 –

### Completed Transition and Penetration Sealing

This close aerial view documents completed sealing work at a roof transition and nearby roof penetrations. The roof-to-metal connection area was cleaned and sealed to reinforce the transition between the different roof systems. Visible penetrations were also prepared and sealed as part of the completed repair scope. The finished conditions shown in this photograph appear continuous and serviceable at the time of inspection, with the restoration work intended to reduce potential points of water intrusion.
