## 5 YEAR ROOF CERTIFICATION & REMAINING USEFUL LIFE ASSESSMENT

Mike McGilvary Roofing, Inc., hereinafter referred to as "MMR", hereby submits the following inspection, scope of work performed (if any) and certification:

## PHOTO EXHIBIT ONE (1) – SUPPORTING DOCUMENTATION

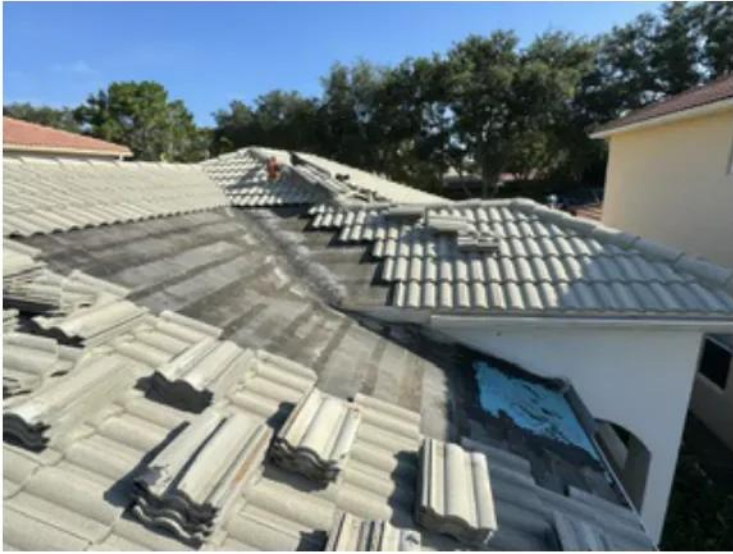
### Area 1 – Valley / High Water Flow Area

Primary roof valley serving as a high water flow drainage area.

Evidence of prolonged water migration and staining within the valley.

Visible traffic wear from previous service activity. Previous repair observed at the lower section of the valley.

Previous repair had failed to stop water intrusion, with leakage continuing at this location. Roofing system opened for investigation, repair, and reconstruction due to continued active leakage.

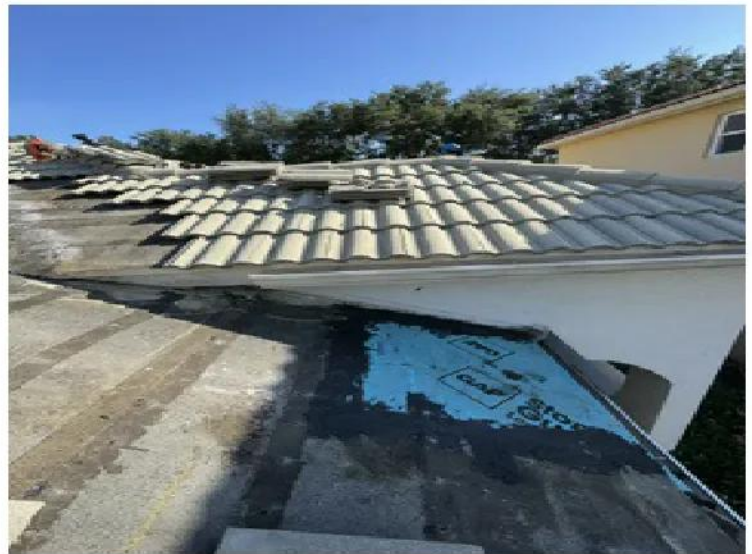
Evidence of a previous repair attempt within the roof valley/high water flow area.

Previous repair did not resolve the source of water intrusion.

Active leakage continued despite the prior repair.

Roofing materials were opened for investigation to identify the underlying failure and prepare the area for proper repair and reconstruction.

Visible water staining and deterioration are consistent with ongoing moisture intrusion following the unsuccessful repair.

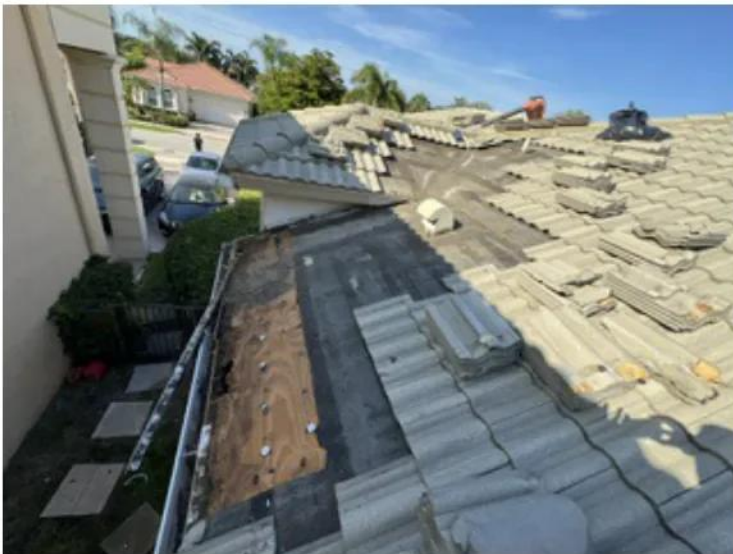
### High Water Flow Area / Deck Deterioration

High water flow area exhibiting evidence of prolonged water intrusion.

Active leak identified during inspection.

Rotted and deteriorated roof sheathing (plywood) observed at the lower section of the roof slope.

Moisture intrusion compromised the roof deck, requiring removal of damaged materials and reconstruction of the affected section.

Conditions are consistent with long-term water infiltration in a concentrated drainage area.

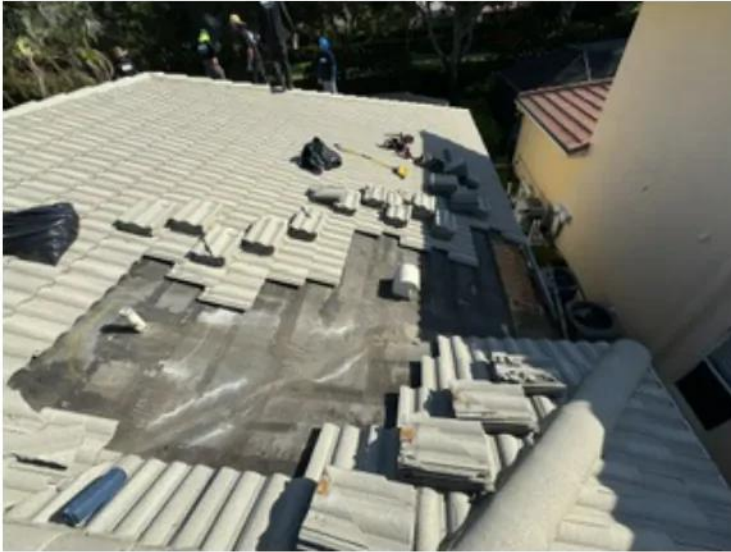
### Valley / High Water Flow Area (Overview)

Overview of the same high water flow valley from the upper roof slope looking downslope. Significant wear and weathering visible throughout the valley due to concentrated water runoff. Evidence of prolonged water migration and deterioration within this primary drainage channel. The lower end of the valley exhibited rotted roof sheathing (plywood) caused by ongoing active water intrusion. This overview documents the extent of deterioration from the top of the valley to the failed roof deck at the lower termination, illustrating the progression of damage prior to repair.

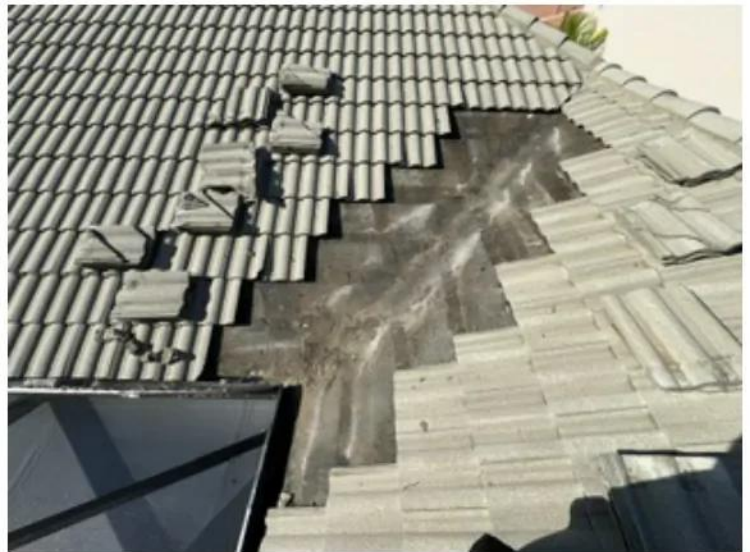
### Valley / High Water Flow Area

Primary roof valley exhibiting advanced wear associated with concentrated water runoff. Deterioration is isolated within the valley, where the roofing system experiences the highest volume of water flow. Evidence of prolonged water migration and deterioration extends toward the lower termination of the valley. The spread of damage at the bottom of the valley is consistent with chronic moisture intrusion in this high-flow drainage area.

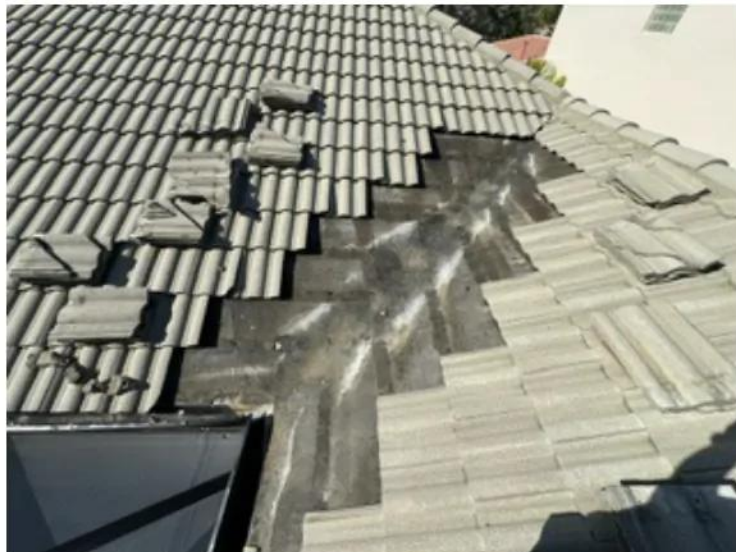
Secondary overview of the same roof valley showing deterioration from the upper roof slope.

Wear is concentrated within the valley, a primary high water flow area, while the surrounding field roof remains in better condition.

Damage becomes more pronounced at the lower termination of the valley where water concentrates, resulting in active water intrusion and deterioration of the roofing system.

This condition required removal of the affected materials for proper repair and reconstruction.

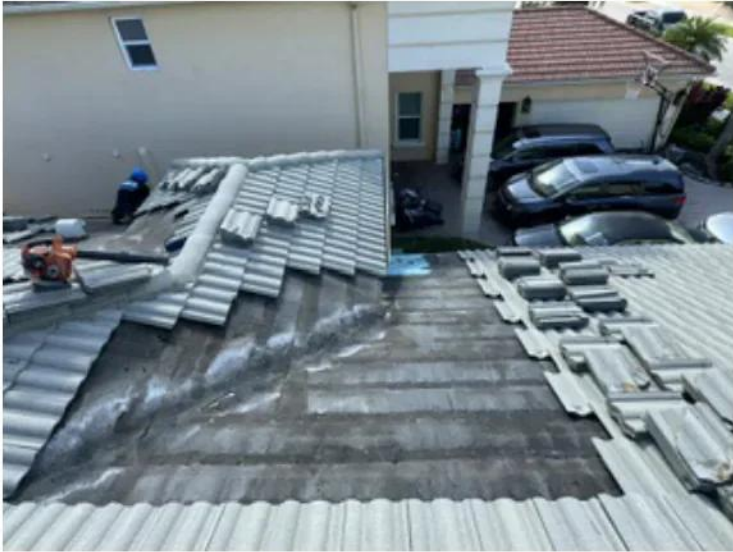
### Valley / High Water Flow Area

Additional roof valley exhibiting deterioration within a primary high water flow area.

Wear and water staining are concentrated along the valley, consistent with prolonged exposure to heavy water runoff.

The lower section of the valley showed evidence of active water intrusion and deterioration requiring repair. The affected roofing materials were removed to allow proper reconstruction and restoration of the roof system.

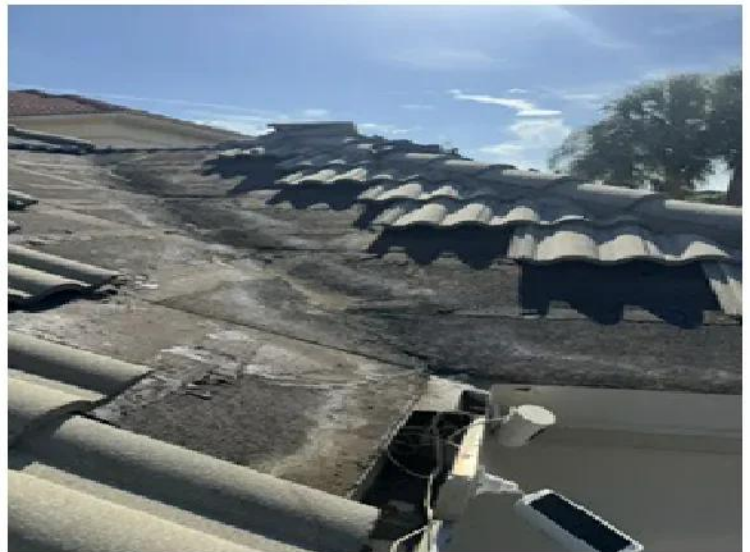
### Valley / High Water Flow Area

Additional roof valley exhibiting deterioration within a primary high water flow area

Wear and weathering are concentrated along the valley where the greatest volume of water is discharged during rain events.

Evidence of prolonged moisture intrusion was observed, with deterioration extending toward the lower termination of the valley.

The affected roofing materials were removed to facilitate proper repair and restoration of the roof system.

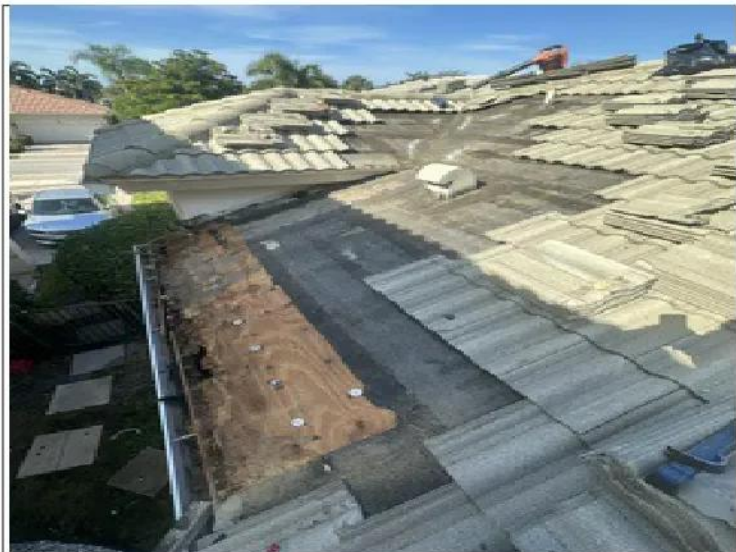
**High Water Flow Area (Before Repair)**

Initial view of a failing high water flow area prior to repair.

Significant deterioration was observed within the drainage path, with active water intrusion resulting in rotted roof sheathing (plywood) at the lower section.

The affected roofing materials were removed to expose the damaged deck and prepare the area for reconstruction.
