5 YEAR ROOF CERTIFICATION & REMAINING USEFUL LIFE ASSESSMENT

Owner's Name:		Property Address: <p style="text-align: center;">Palm Beach, FL</p>		Roof Type: <p style="text-align: center;">Concrete Tile & Flat</p>	
Contact Email:		Contact Phone #1:	Contact Phone #2:	Approx. Roof Age: <p style="text-align: center;">25 YEARS</p>	
INSPECTION DATE 5/26/2026	CERTIFICATION NUMBER MMR- 05262026	DATE OF EXPIRATION 5/26/2031	INSPECTOR LICENSE NO. CCC1331721	INSPECTOR NAME Mike McGilvary

PHOTO EXHIBIT ONE (1) – SUPPORTING DOCUMENTATION

**EXISTING ROOF CONDITIONS –
AERIAL PHOTOGRAPHIC RECORD**

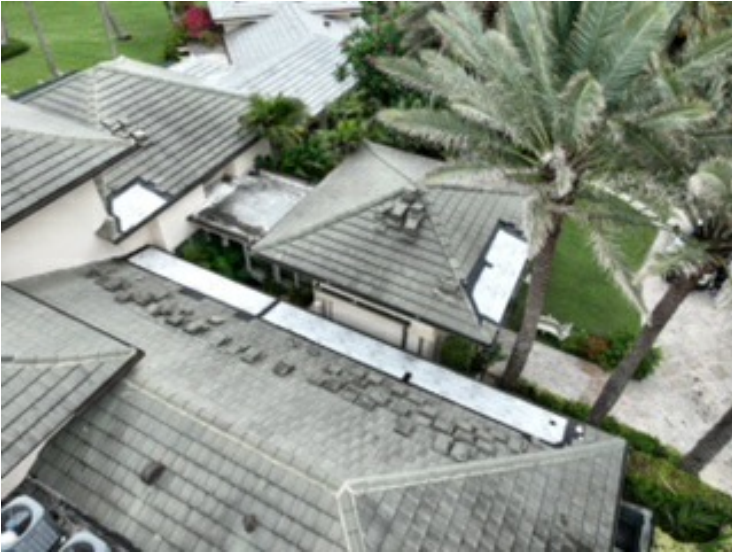
**PROJECT EXECUTION
&
REBUILT AREA OVERVIEW**

Aerial overview of the property following completion of multiple roof rebuild sections.

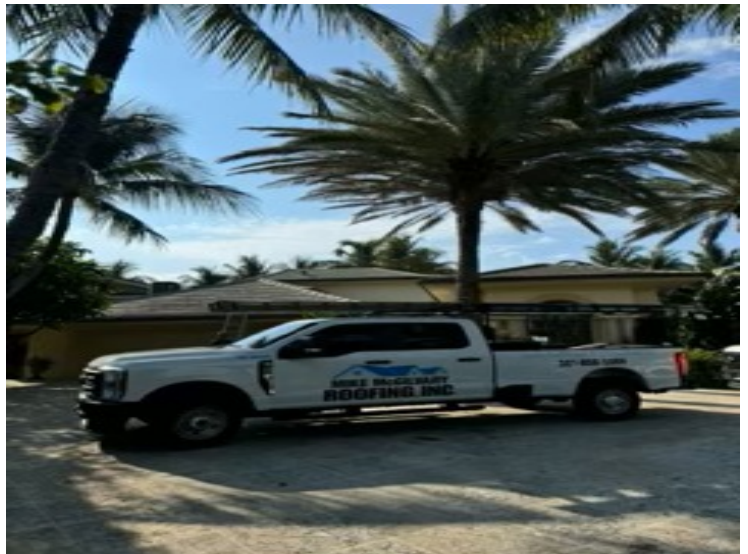
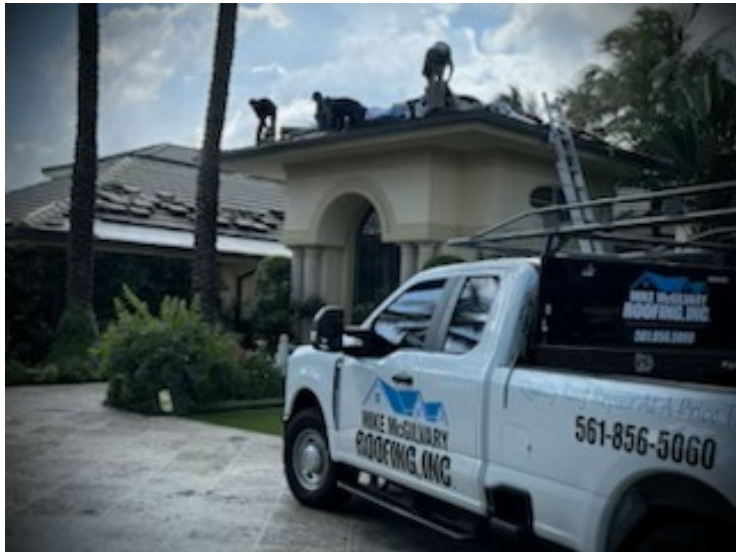
Active Roof Restoration Operations

Roofing personnel performing restoration and rebuild work on identified sections of the roof system.

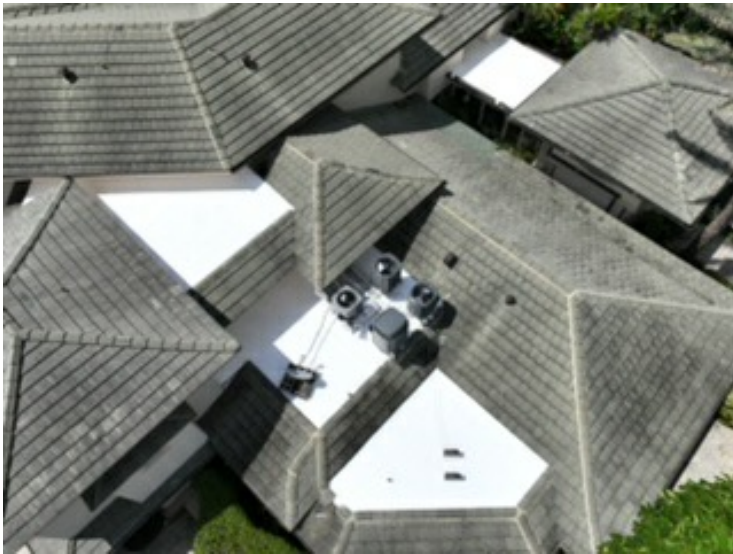
Comprehensive Roof System Restoration

Aerial overview highlighting the completed roof preservation program, including rebuilt high-water-flow sections, restored flashing systems, and professionally recoated low-slope roof areas.

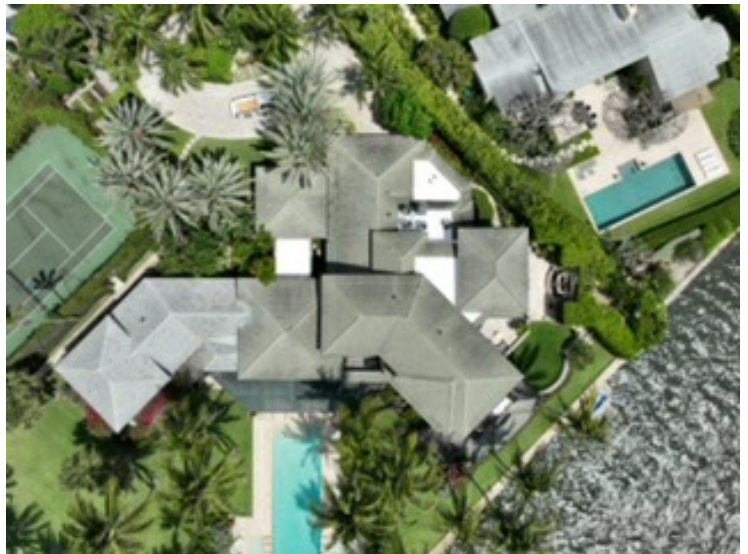
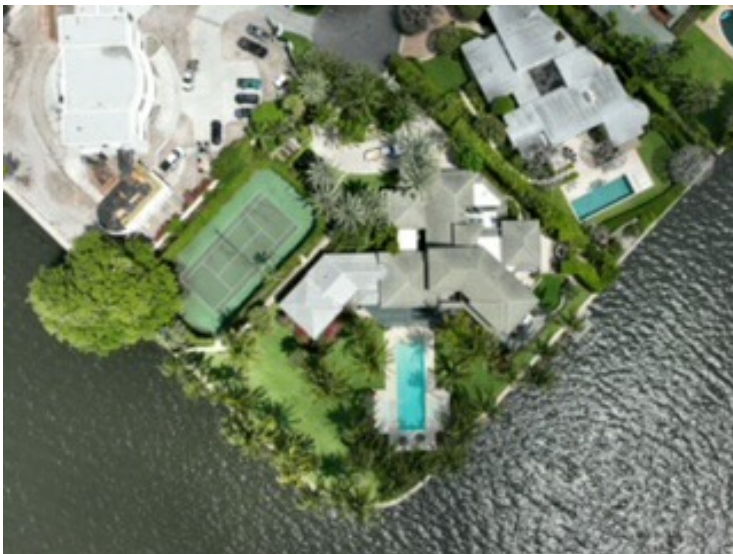
Project Completion & Five-Year Certification

Final aerial overview of the completed restoration. Through targeted reconstruction of deteriorated areas, installation of new waterproofing materials, and application of commercial-grade silicone roofing systems, the roof was restored to a serviceable condition and qualified for issuance of a Five-Year Transferable Roof Certification at the time of inspection.
